FLOOD OF 31 JULY 1976
IN
BIG THOMPSON CANYON, COLORADO

D. B. Simons, J. D. Nelson, E. R. Reiter, and R. L. Barkau

Committee on Natural Disasters
Commission on Sociotechnical Systems
NATIONAL RESEARCH COUNCIL

National Academy of Sciences
Washington, D.C.
1978

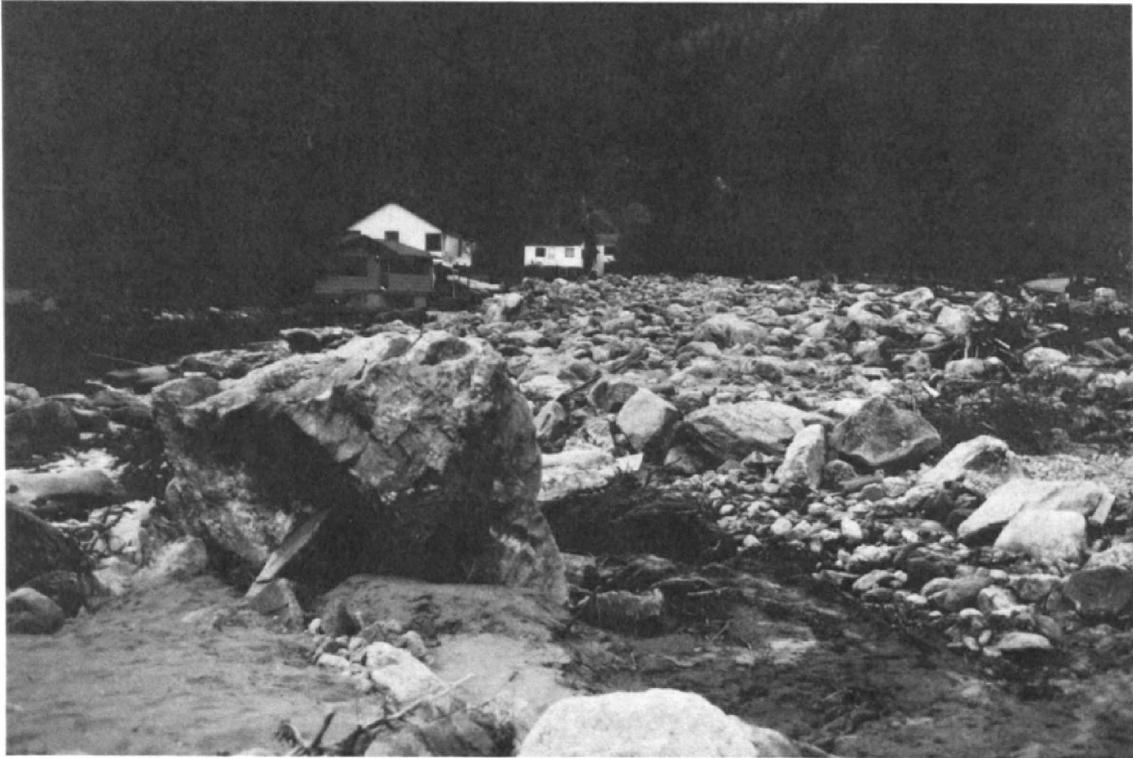
FIGURE 14 Boulder Deposit Upstream of Drake

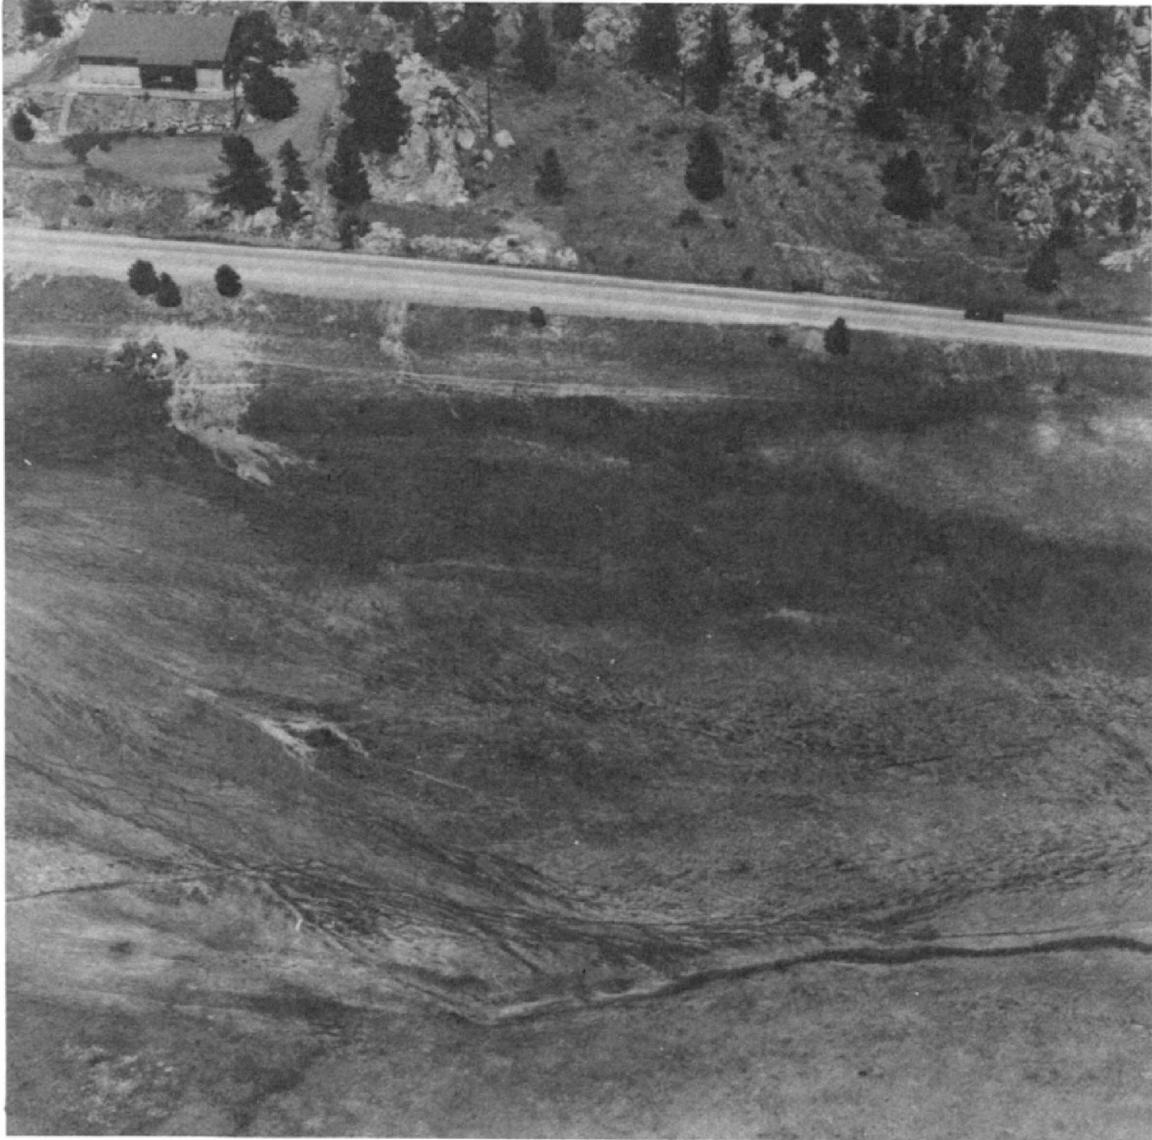
Sheet erosion results from the suspension of fine surface materials by overland flow. Sheet erosion most commonly occurs on the gentle to moderate (5 to 15%) slopes where rainfall is so intense that the infiltration capability of the soil is exceeded. Poorly developed soils of granitic origin (gruss) with little vegetative cover are subject to severe erosion. During the 1976 flood, sheet erosion removed almost 6 inches of gruss from intense rainfall areas (Doehring 1976). Soils that had developed from the weathering of metamorphic rocks were less susceptible to severe erosion. On steeper slopes sheet erosion was replaced by rill wash and gullying. Figure 15 shows an area of sheet erosion along Dry Gulch near Estes Park.

FIGURE 15 Sheet Erosion along Dry Gulch near Estes Park

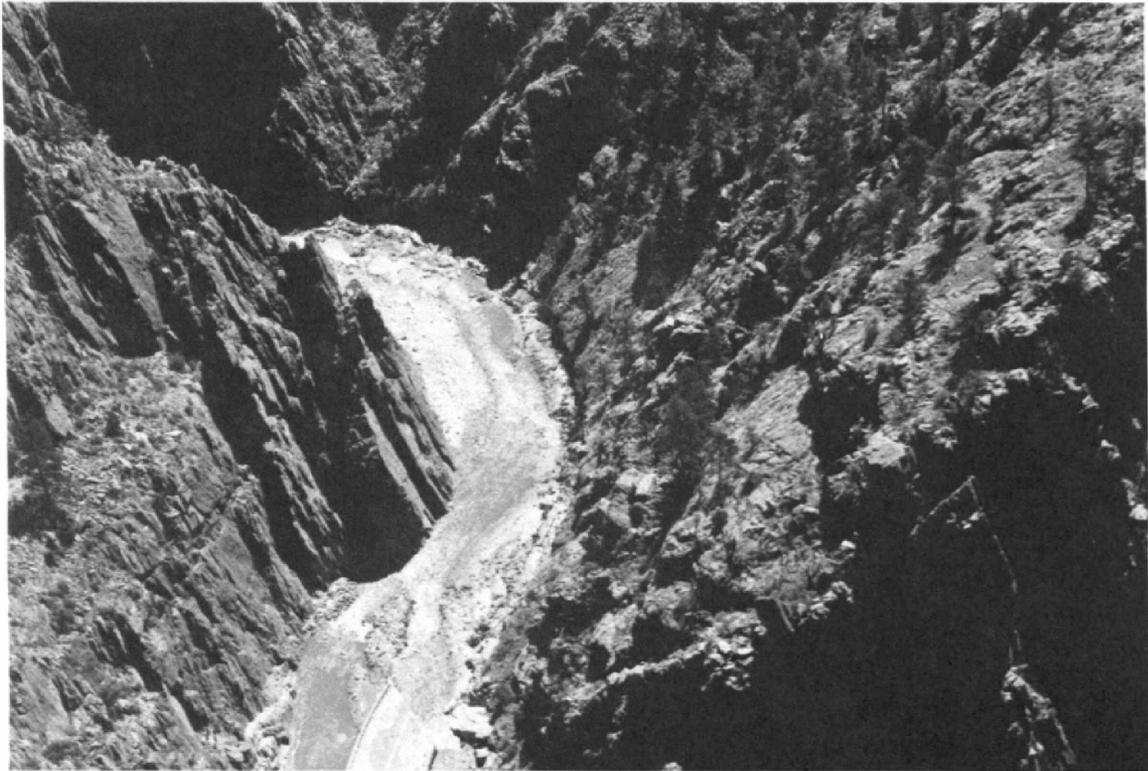
stream's competence (maximum particle size moved by the stream) and its ability to erode and carry sediment. Velocity is related principally to the following factors: cross-sectional area, channel geometry, and stream gradient (slope). Decreasing the cross-sectional area and increasing the stream gradient both increase the velocity. Changes in channel geometry which reduce wetted perimeter also increase velocity. Local changes in velocity can also be significant when flow is concentrated on the outside of bends. In this case, the velocity along the inside is reduced causing deposition to occur, while the velocity on the outside is increased, causing scour (Figure 16).

FIGURE 16 Erosion along Outside and Deposition
along Inside of Stream Bed

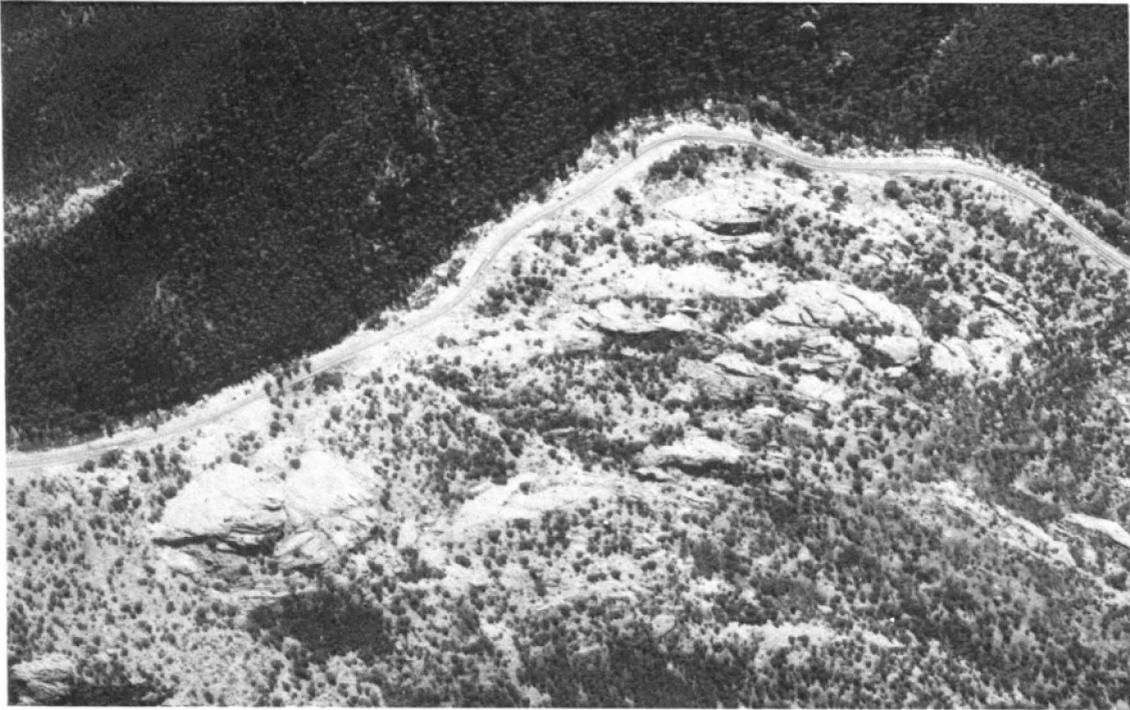
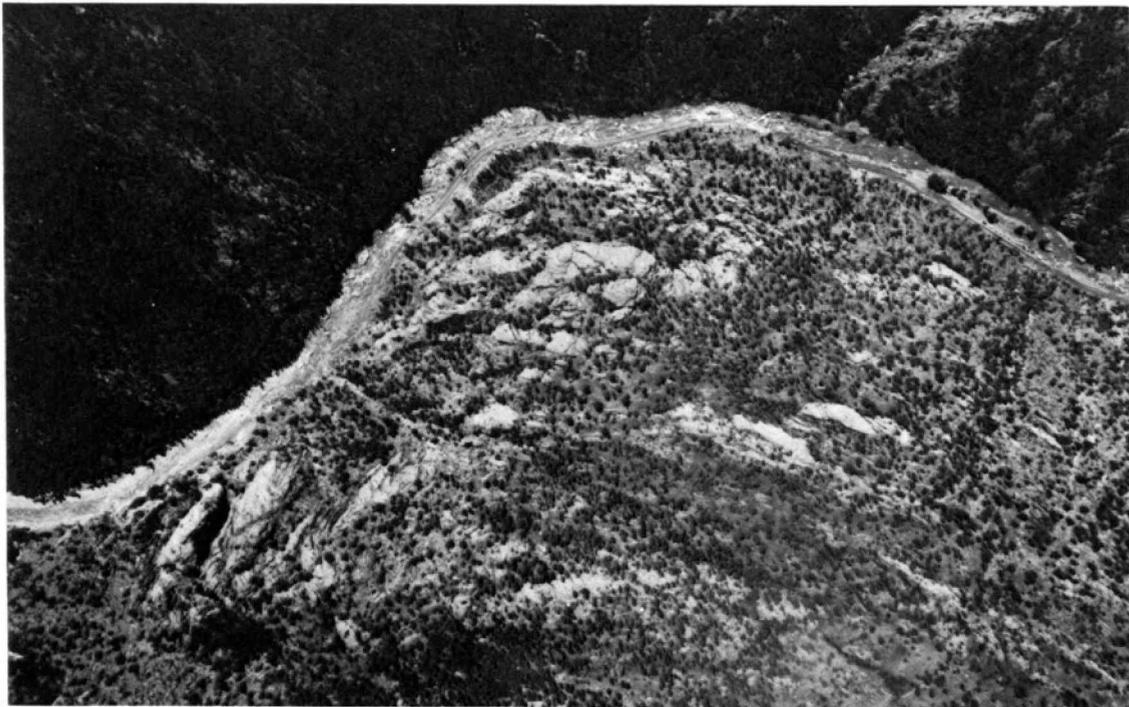
FIGURE 23 Severe Scour along the Big Thompson River above Waltonia

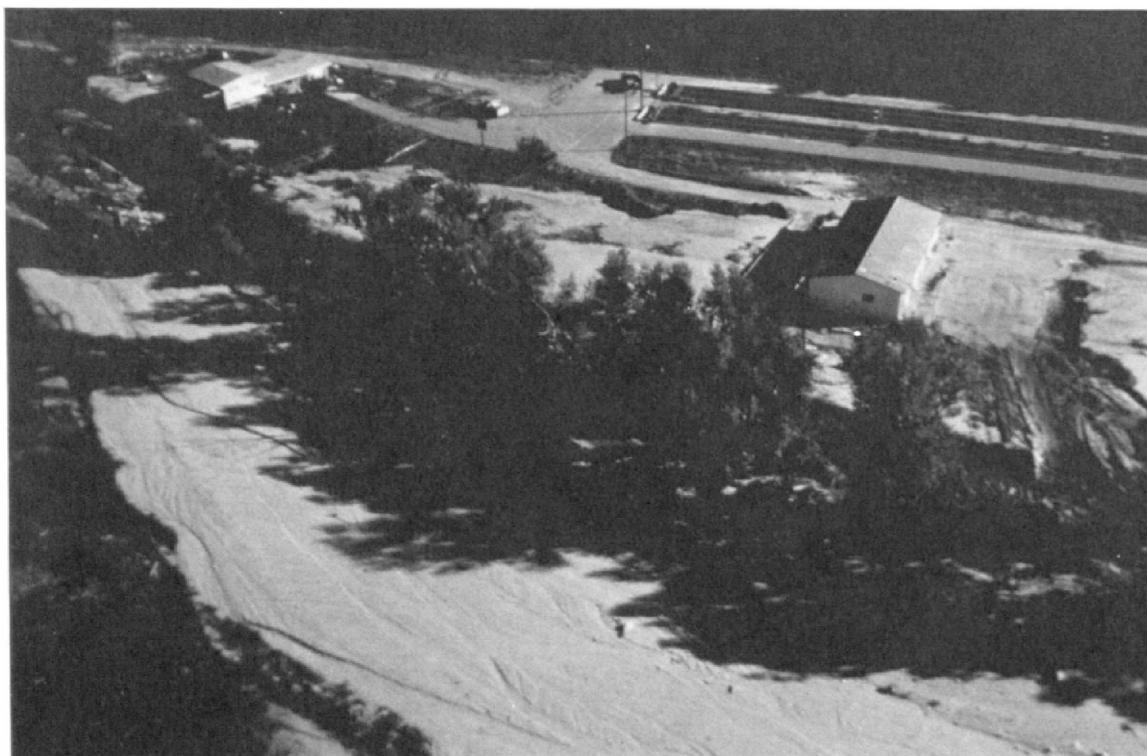
FIGURE 28 Deposits along the North Fork near the Fish Hatchery just Upstream from Drake

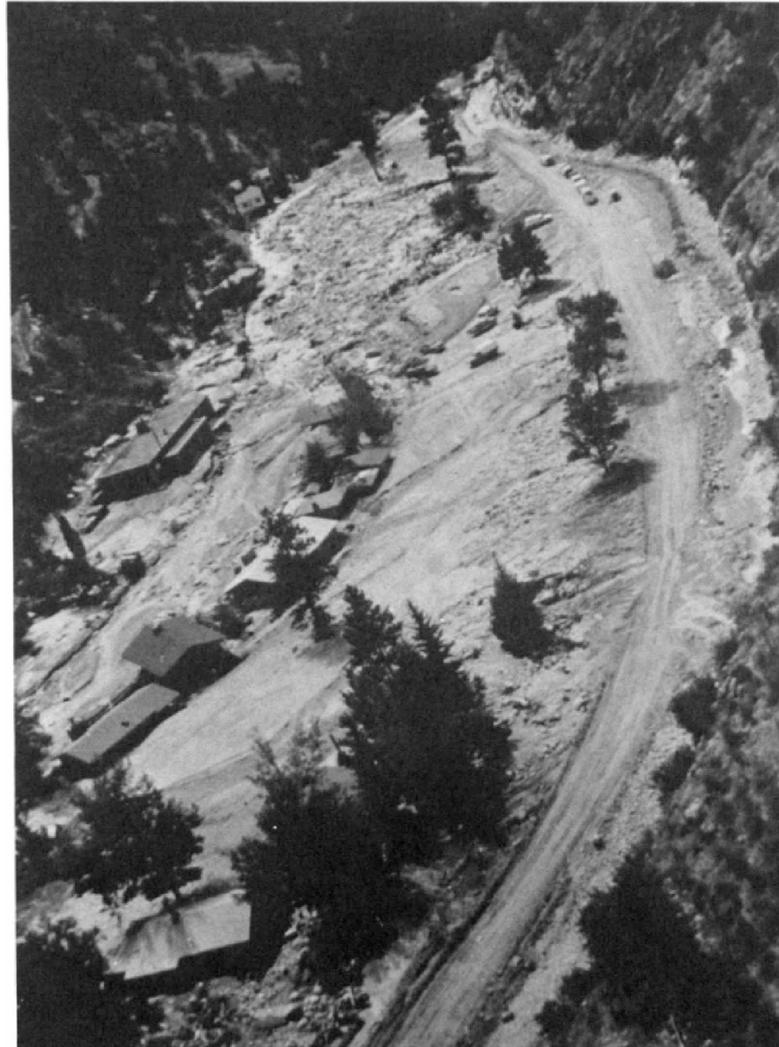
FIGURE 29 Grading of Materials Deposited by the Big Thompson River at Drake

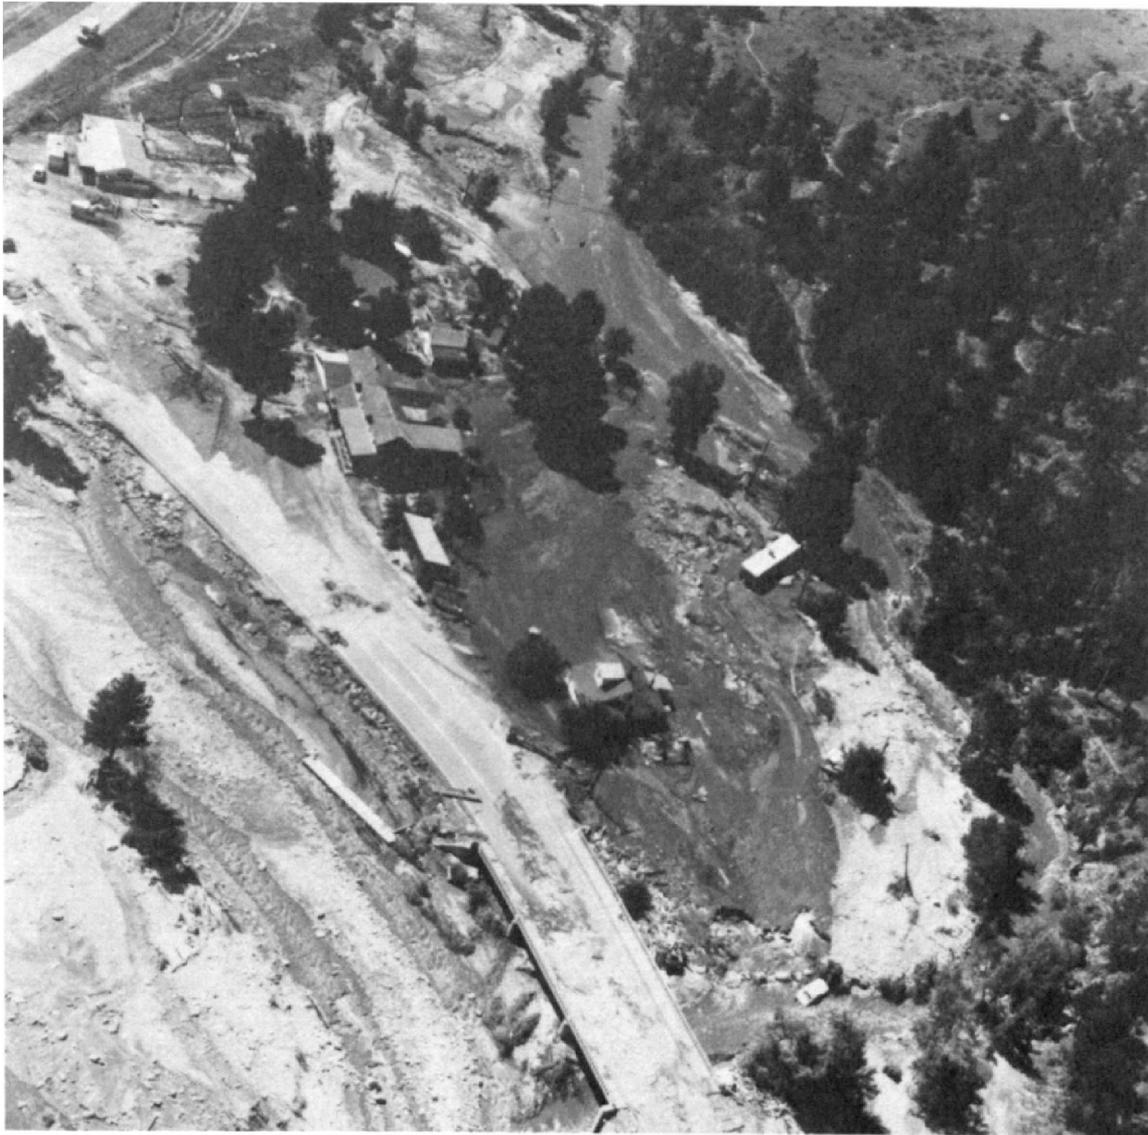
FIGURE 31 Deposits from the North Fork at Drake

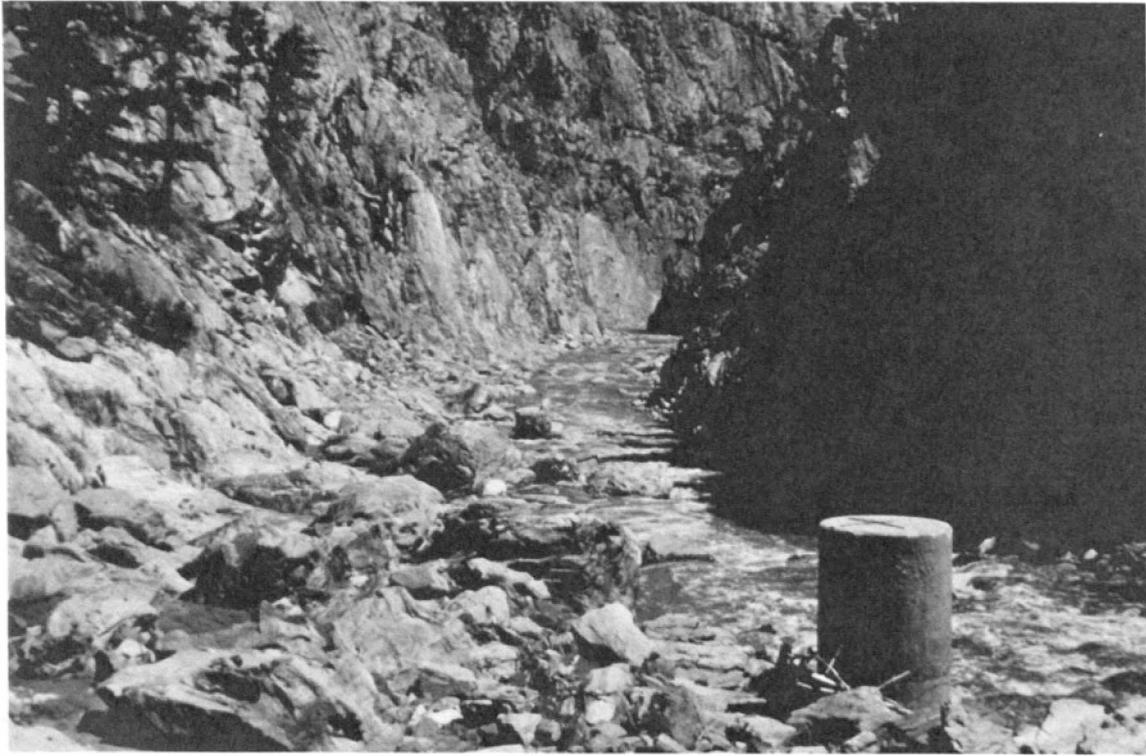
FIGURE 33 Scour in the Narrows Area near the Bureau of Reclamation Diversion Structure

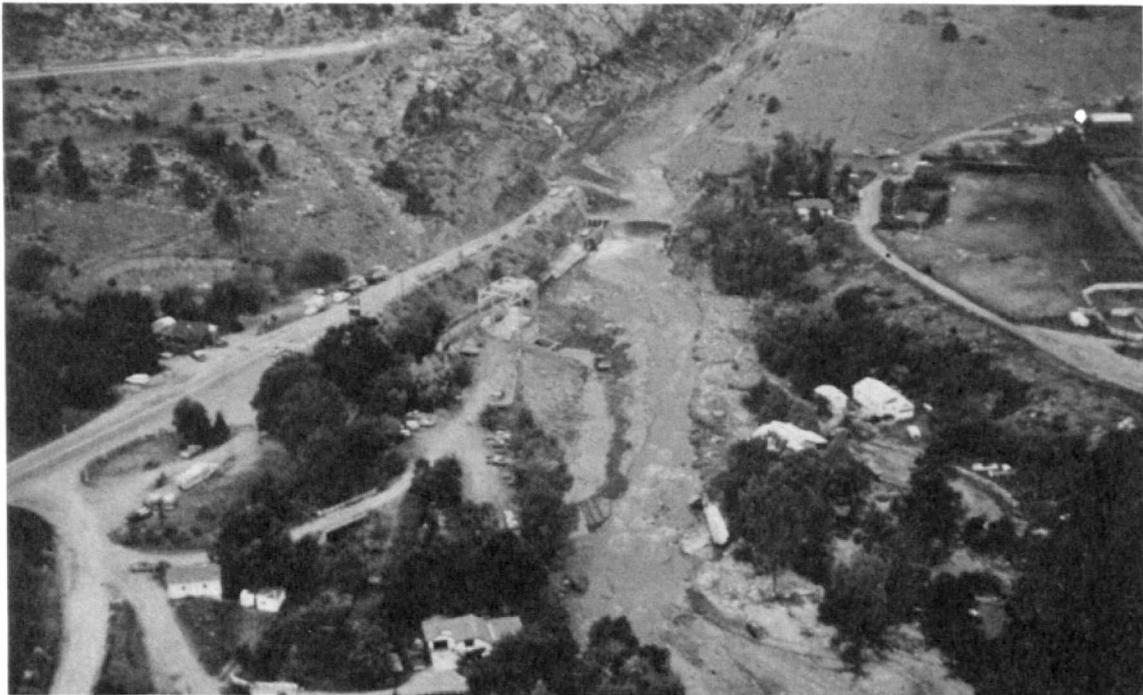
FIGURE 34 Deposits below the Mouth of the Canyon

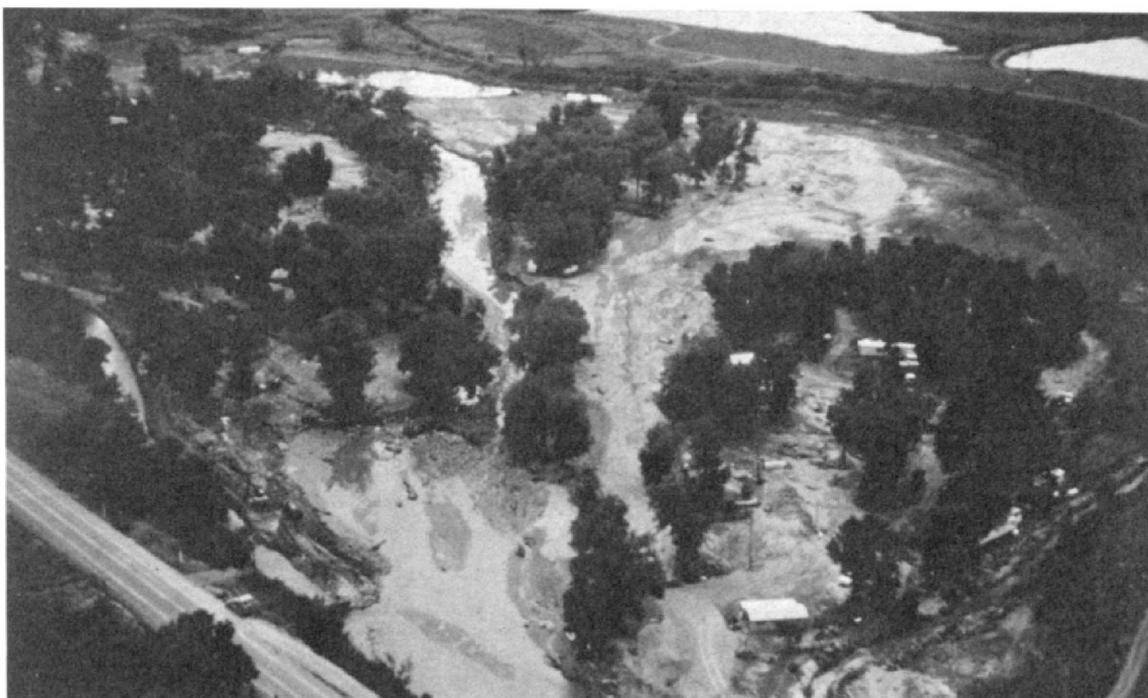
FIGURE 35 Overbank Deposits in the Plains Area

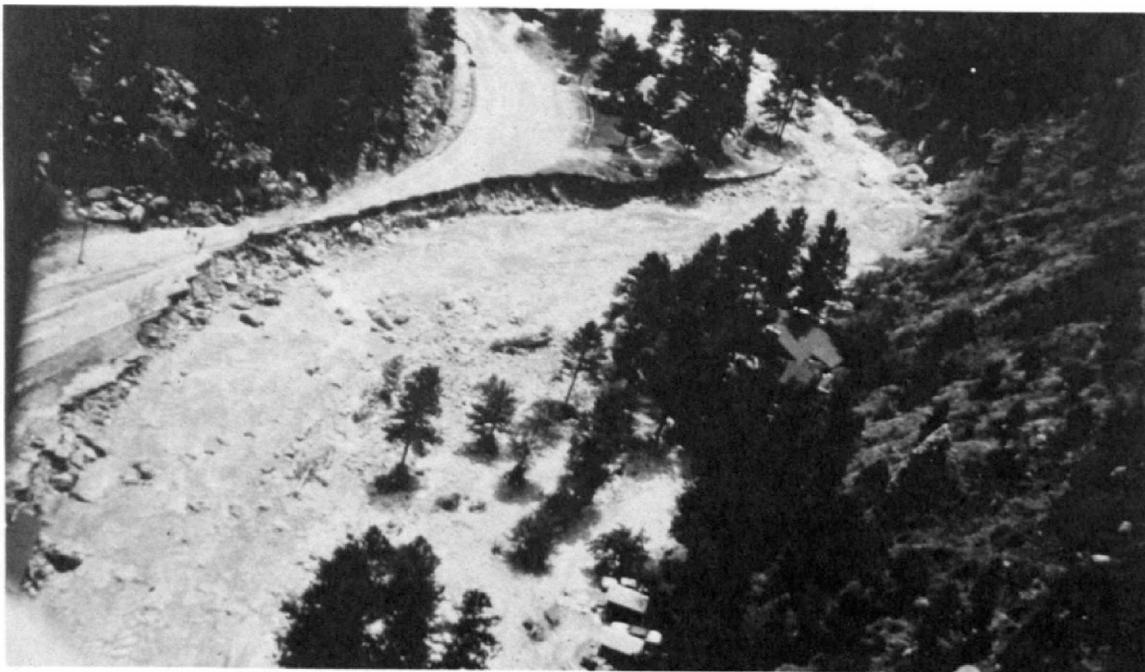
FIGURE 36 Erosion of Outside Bend on U.S. Highway 34

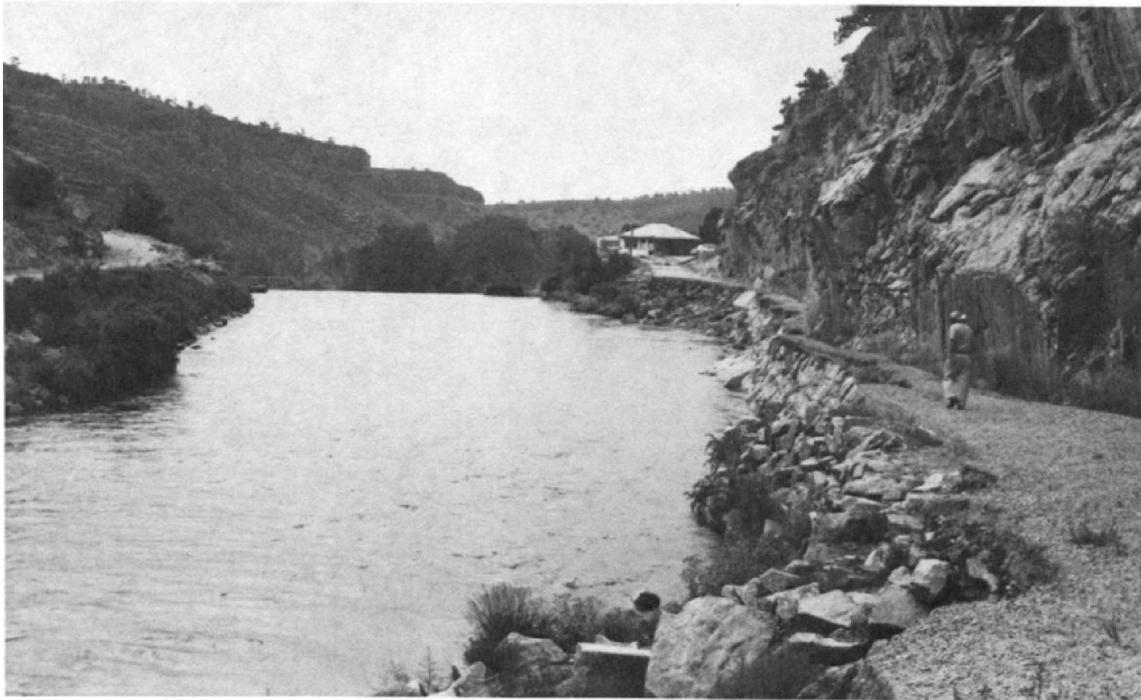
FIGURE 37 Erosion of Road between Bridge and Dam at Loveland Filtration Plant

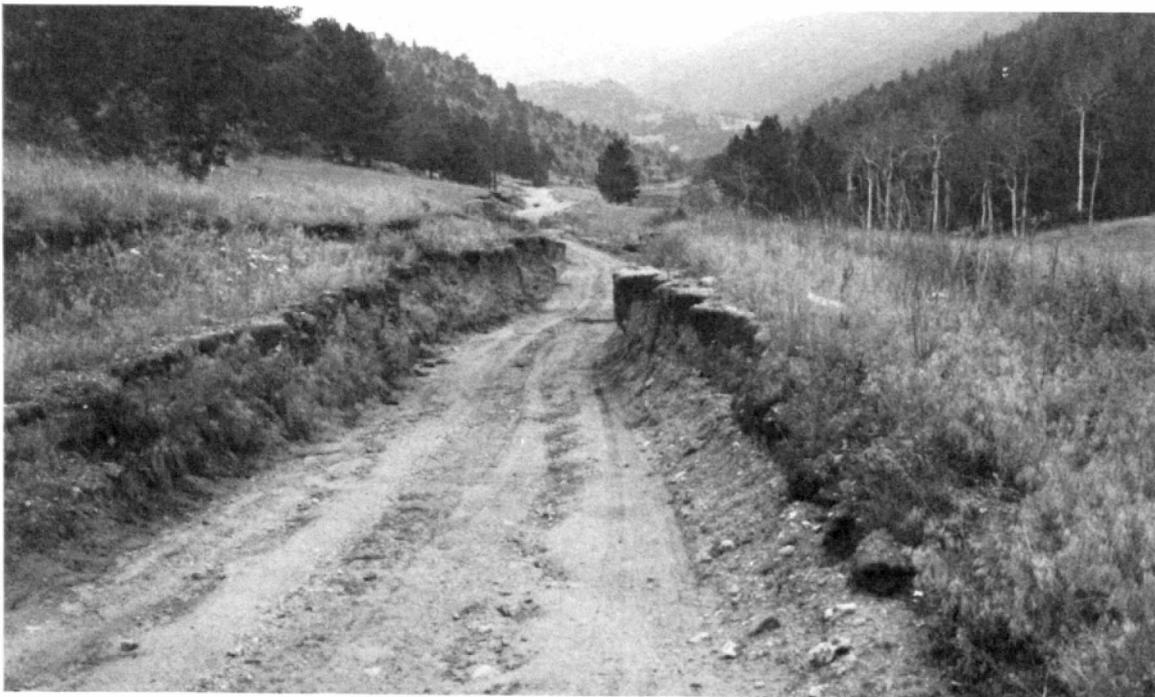
Extensive gullying along roadways was also evidenced in the Dunraven Glade area north of the North Fork. Such gullying can be seen in Figure 39. Extensive erosion was fairly common along roadways or around man-made structures.

FIGURE 39 Extensive Gullying in Dunraven Glade Area

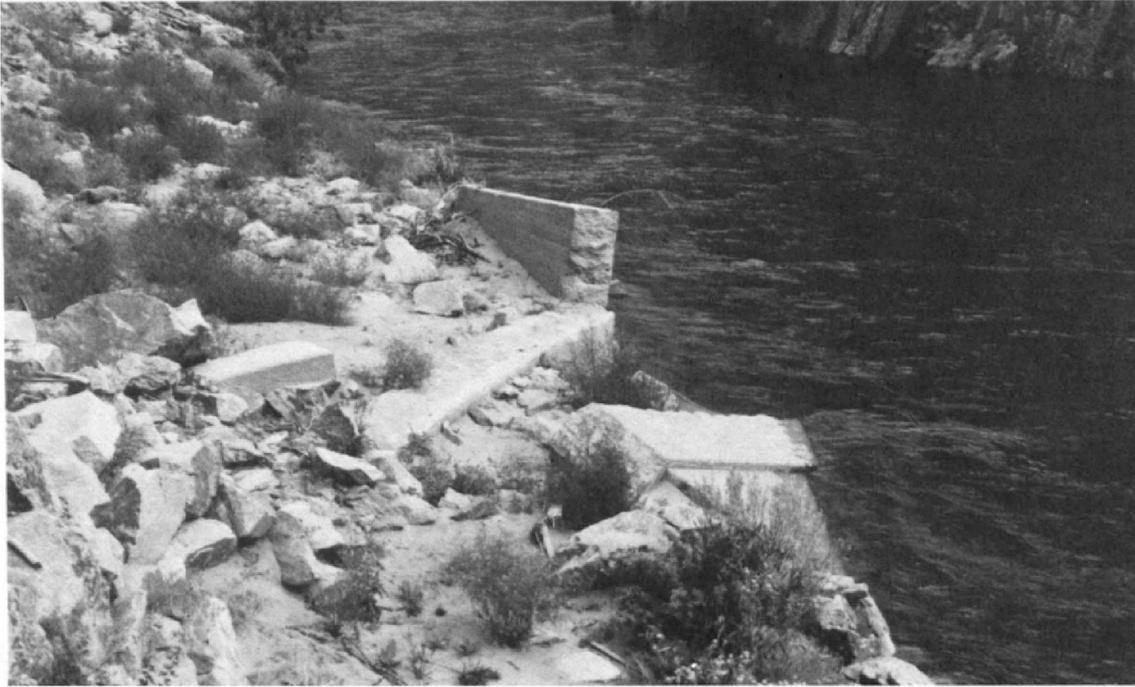
FIGURE 42 Close-up View of Right Abutment Shown in FIGURE 41

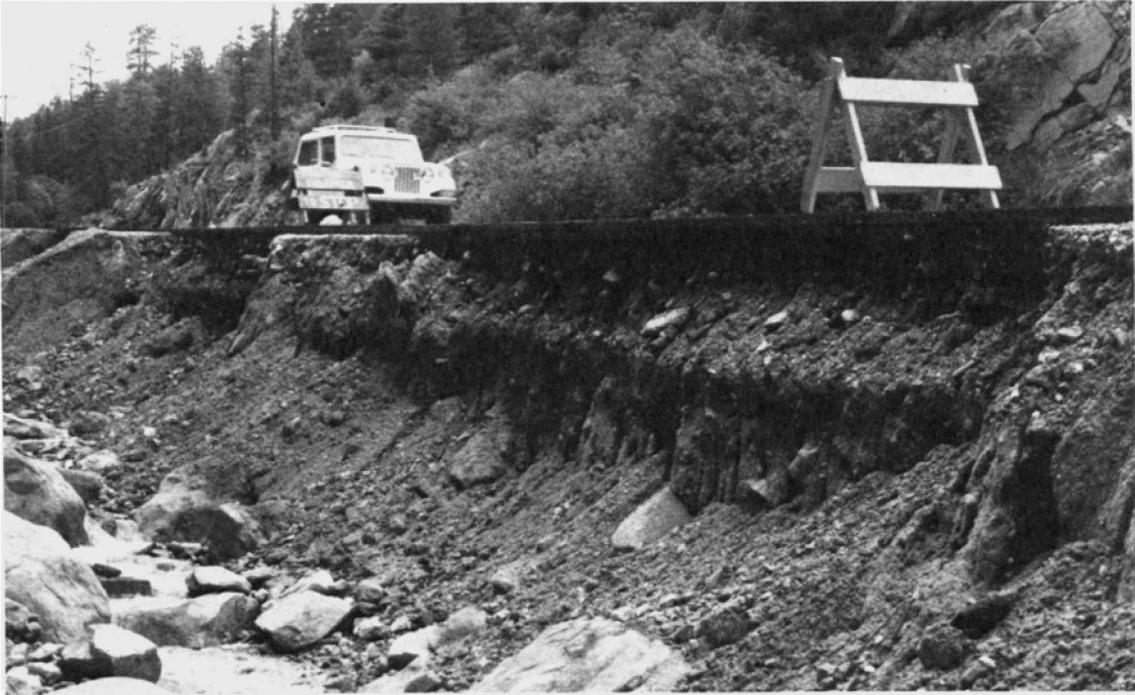
FIGURE 43 Repaired Highway Embankment Washed out by Subsequent Storm

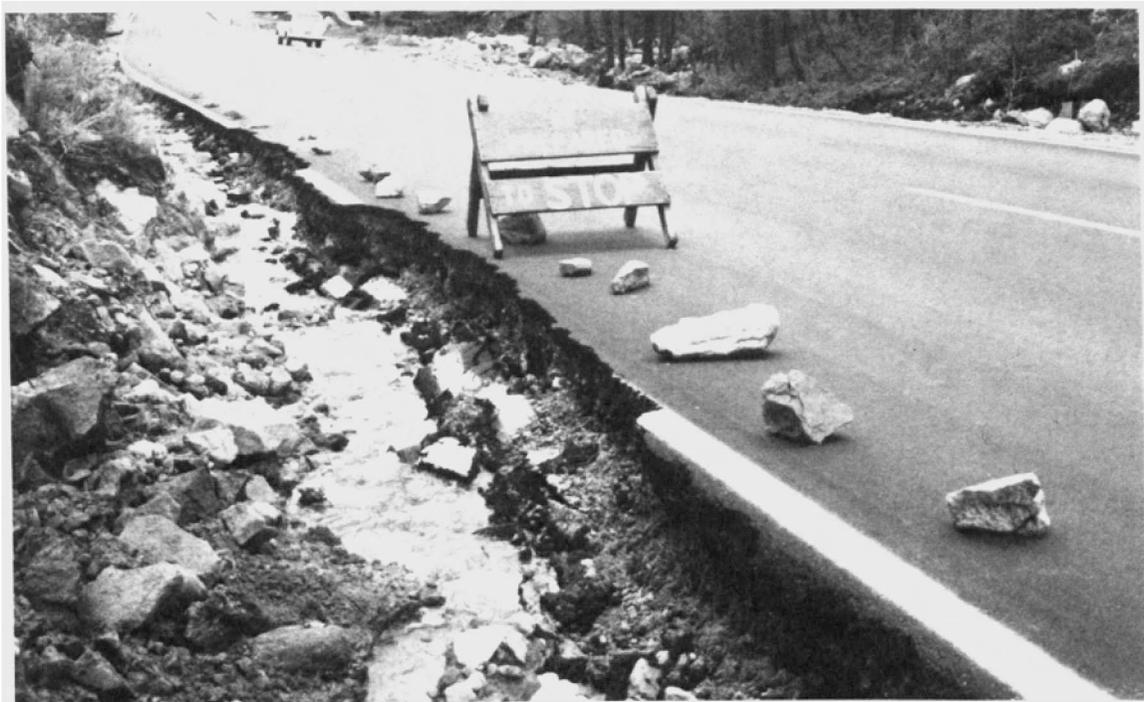
FIGURE 44 Repaired Pavement Eroded by Scour in Drainage Ditch

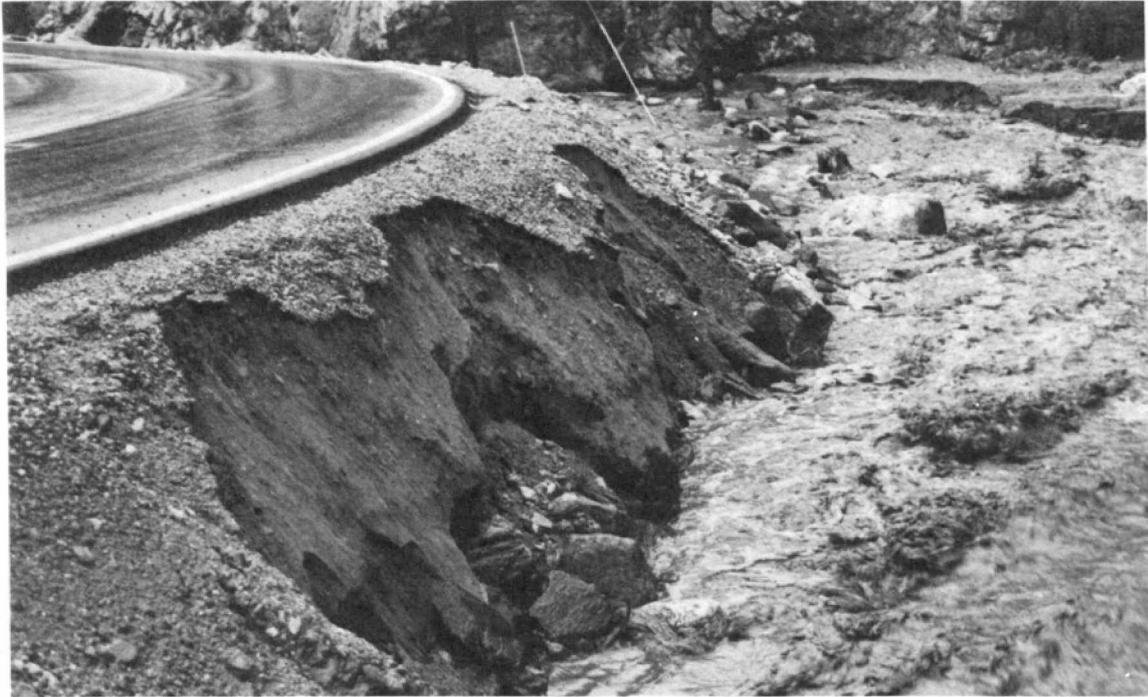
FIGURE 45 Repaired Highway Embankment Eroded by Water from Tributary

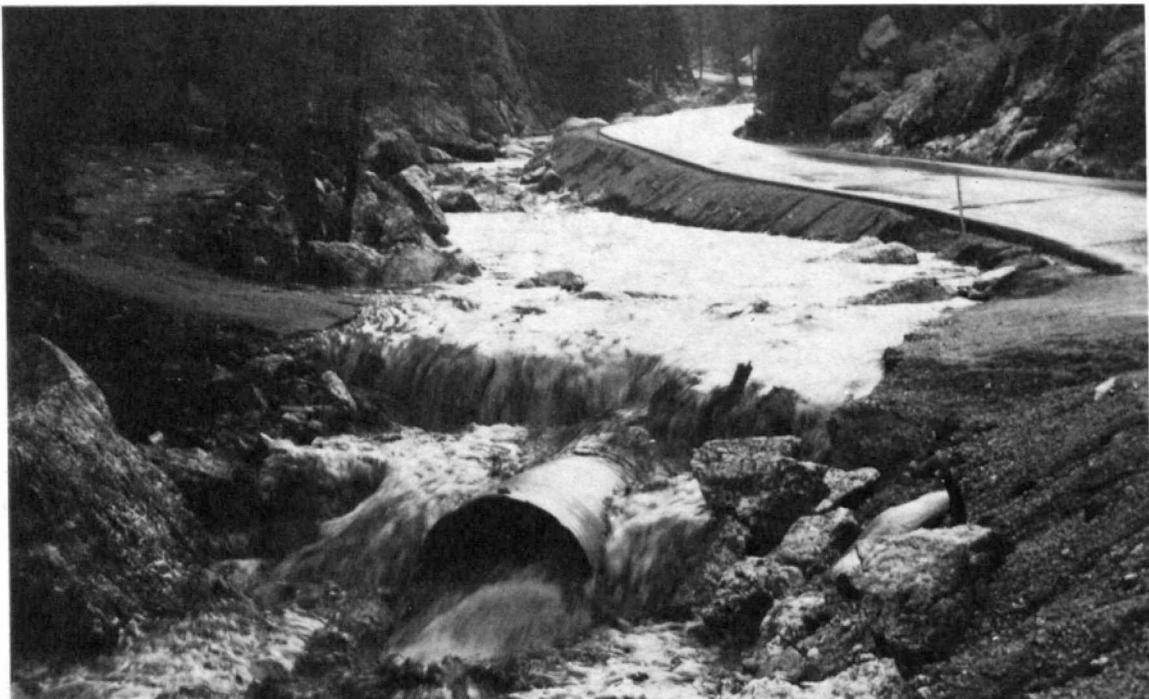
FIGURE 46 Storm Waters Washing over Culvert

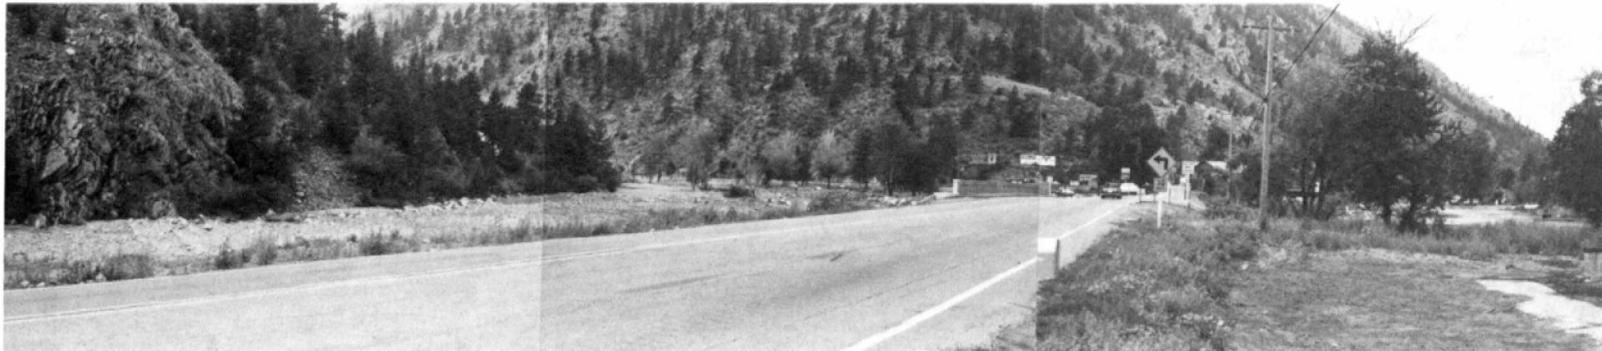
FIGURE 47 Town of Drake after the Flood

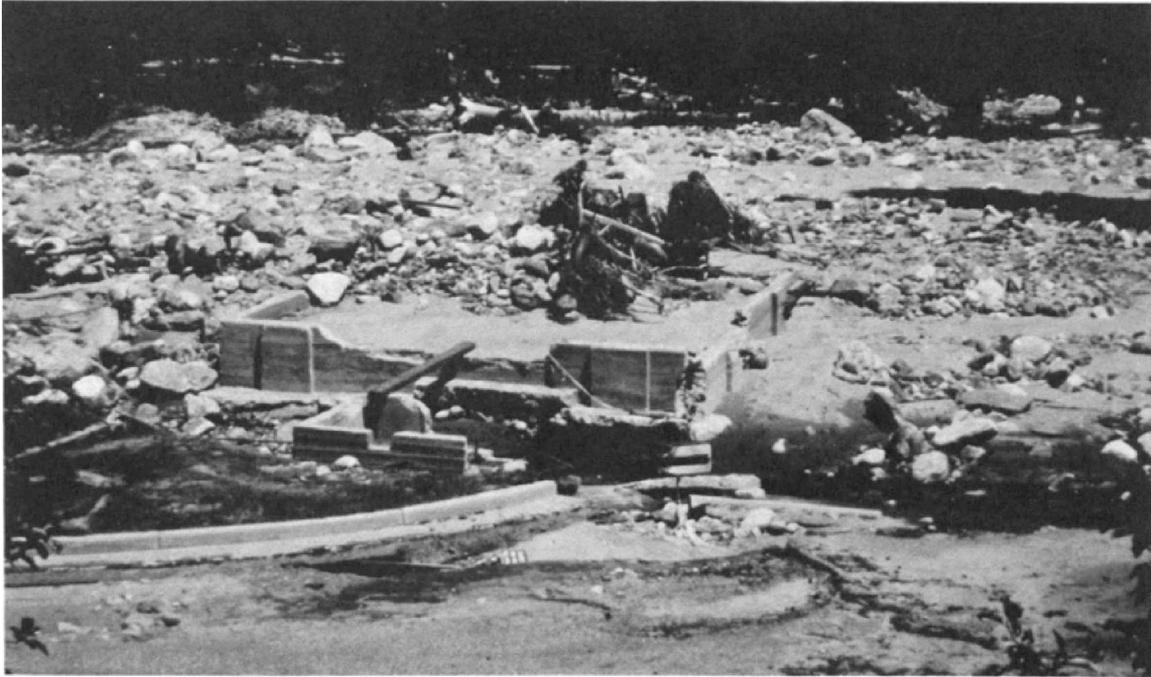
Figure 48 shows the remains of the Loveland City Power Plant. The foundation structure survived well but the entire masonry superstructure and large generators were washed away. Wooden structures were often floated off the foundations and deposited at a different point.

FIGURE 48 Loveland Power Plant

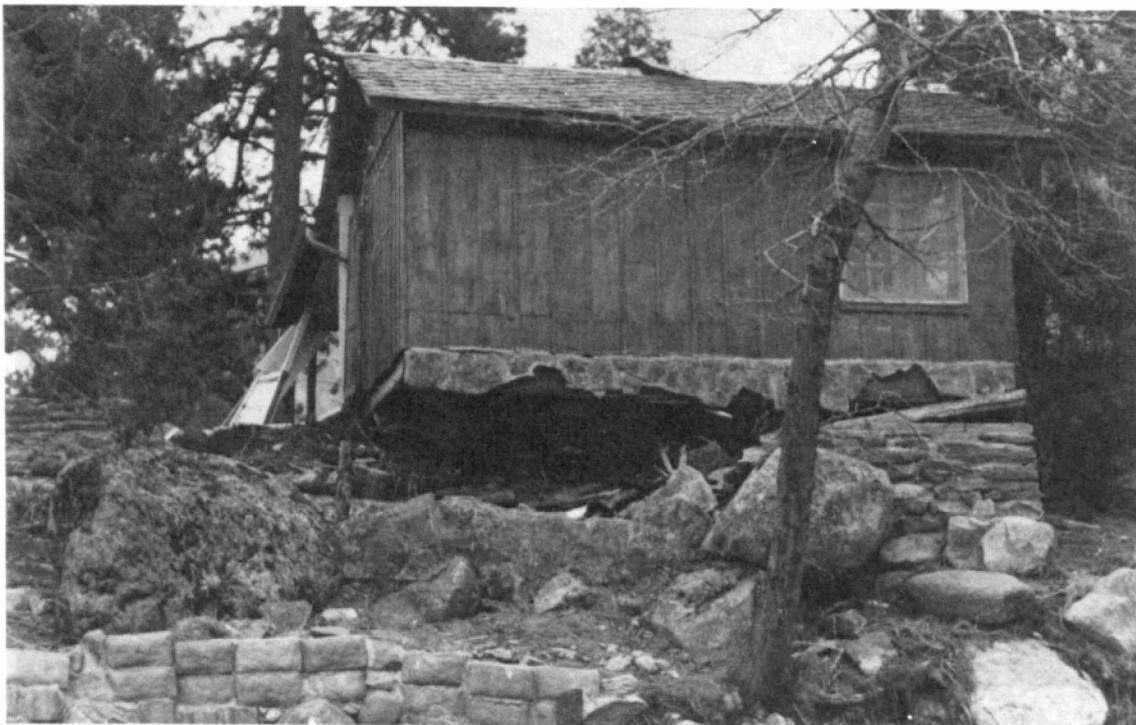
FIGURE 49 Failure of Timber Foundation with Stone Masonry Facing

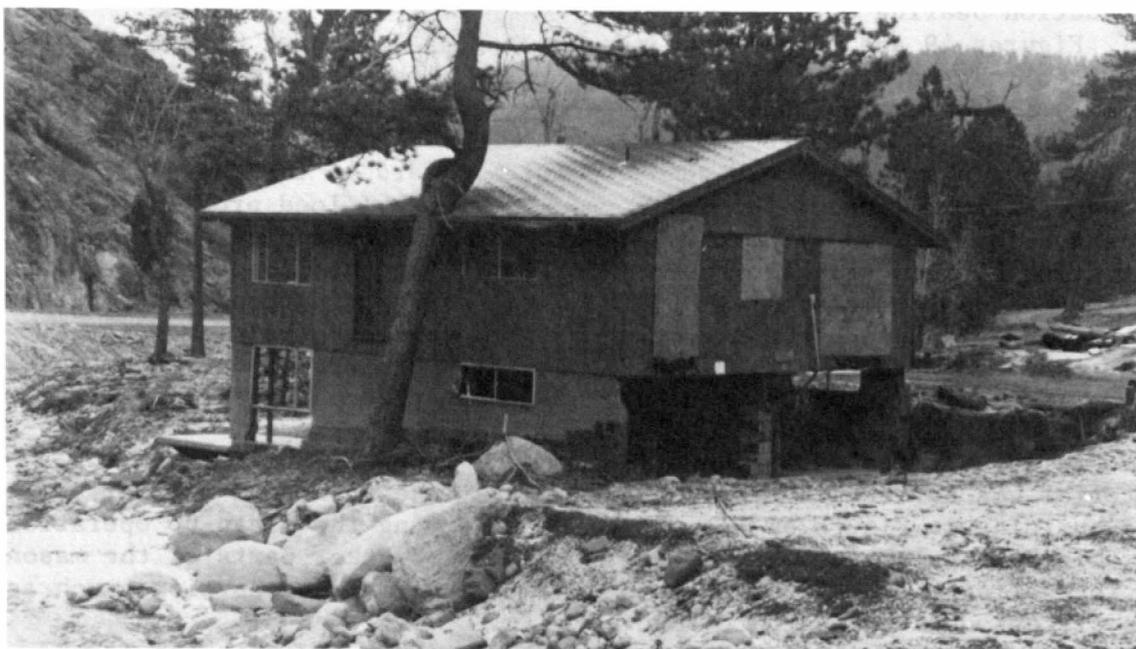
FIGURE 50 Failure of Concrete Block Foundation

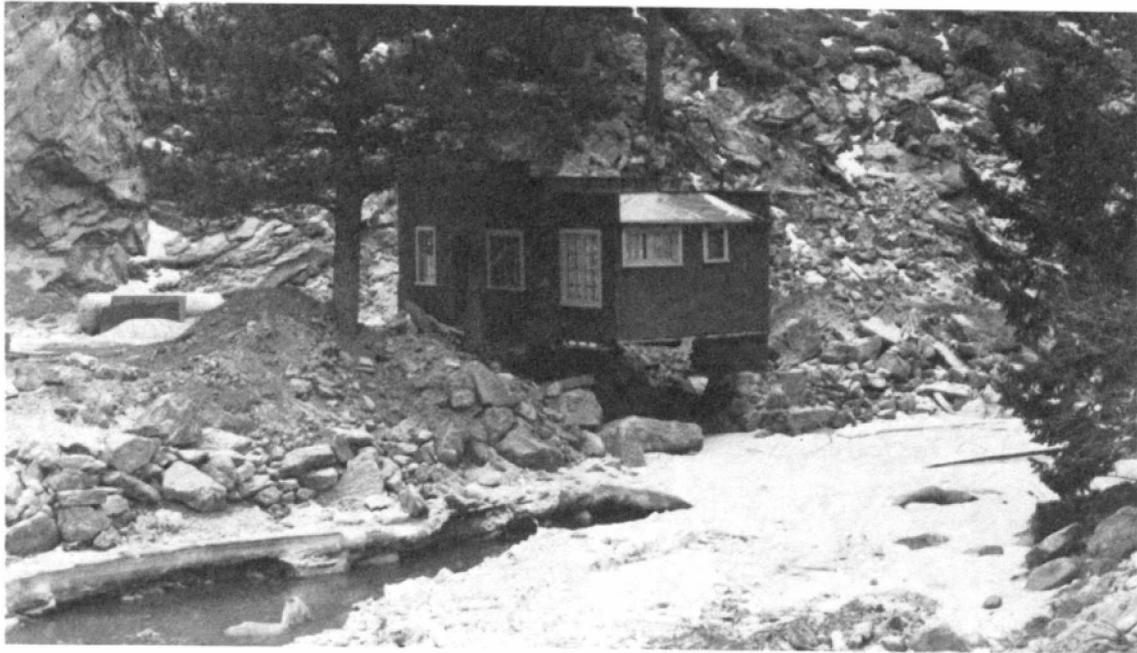
FIGURE 51 Erosion of Foundation Bearing Material

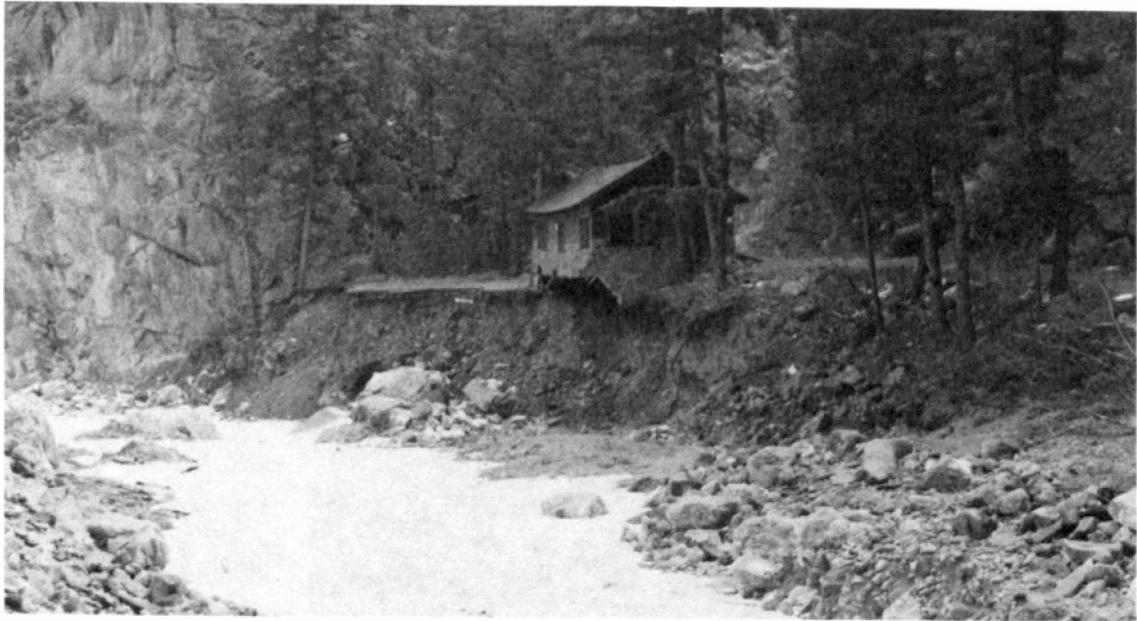
The structure in Figure 52 was constructed on a debris fan formed below a gulch that is normally dry. In the following section this type of failure will be discussed in more detail with regard to slope stability. The point to be made, however, is that, although the floodwaters

FIGURE 52 Erosion of Debris Fan below Foundation

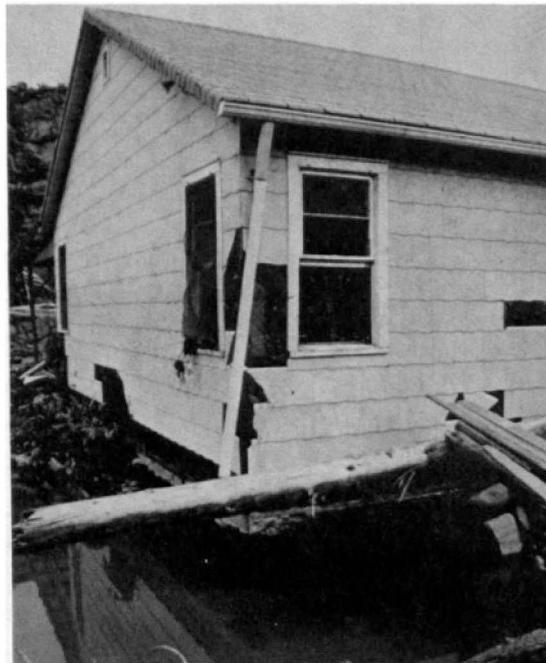
FIGURE 54 Erosion below Slab on Grade Foundation

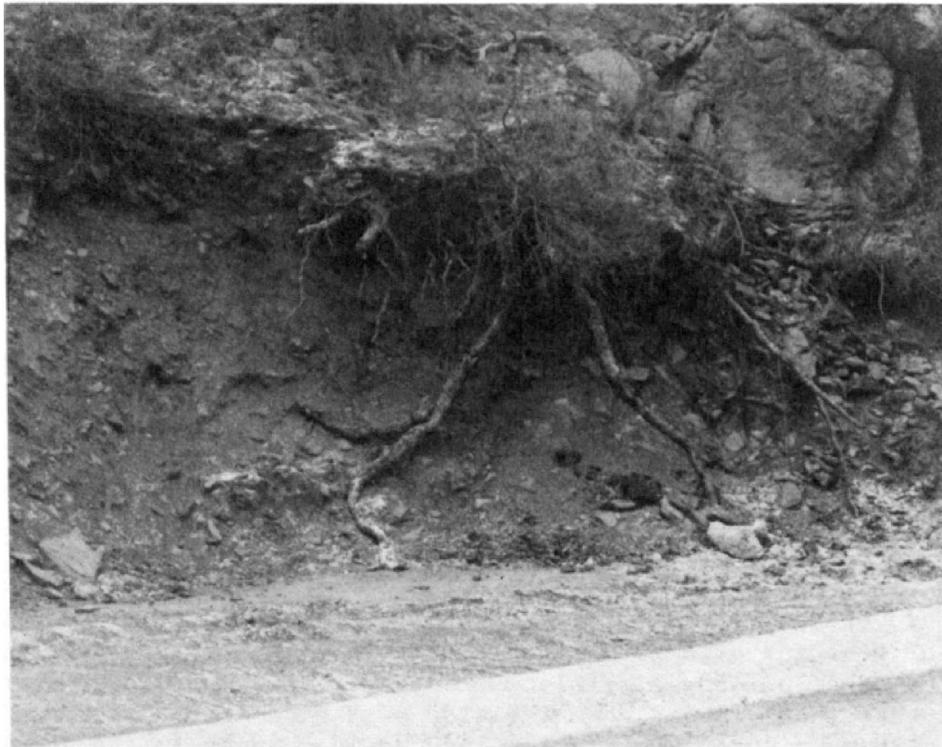
FIGURE 55 Root Zone of Soil Cover
