FLOOD OF 31 JULY 1976
IN
BIG THOMPSON CANYON, COLORADO

D. B. Simons, J. D. Nelson, E. R. Reiter, and R. L. Barkau

Committee on Natural Disasters
Commission on Sociotechnical Systems
NATIONAL RESEARCH COUNCIL

National Academy of Sciences
Washington, D.C.
1978

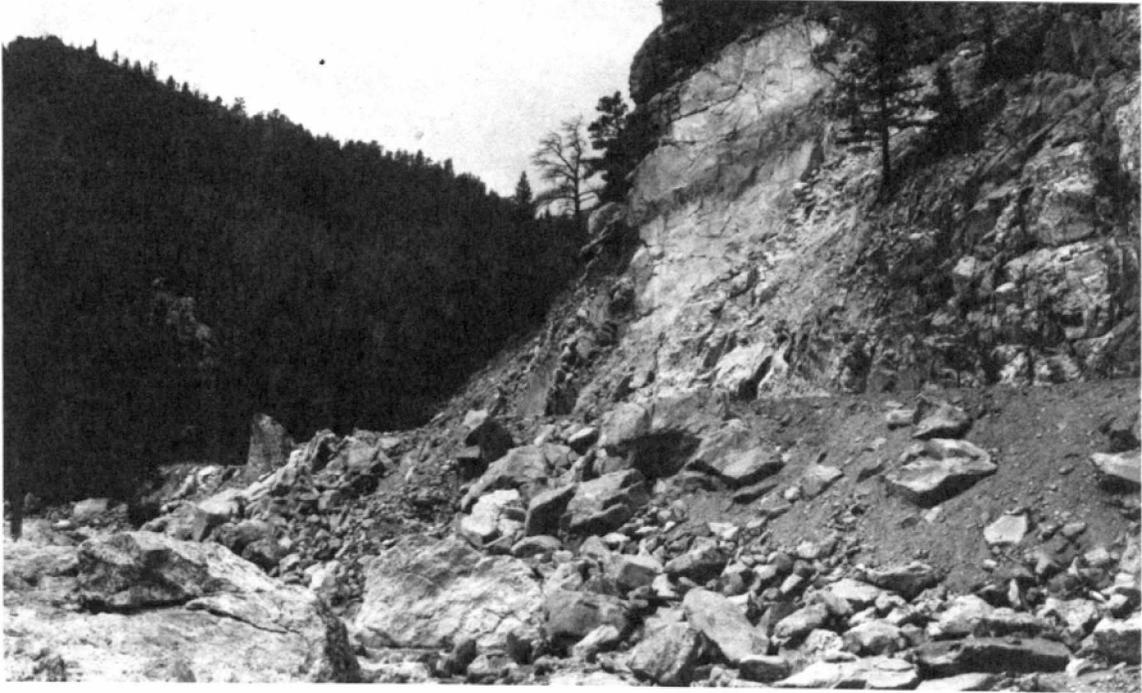
FIGURE 56 Rock Fall along Highway

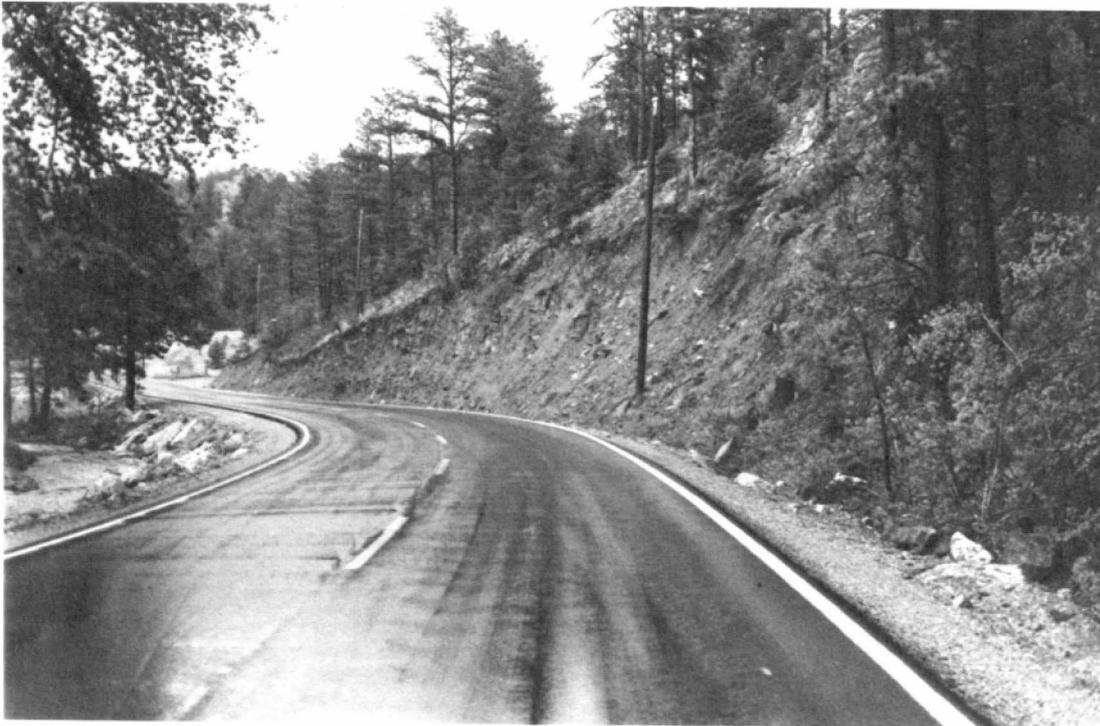
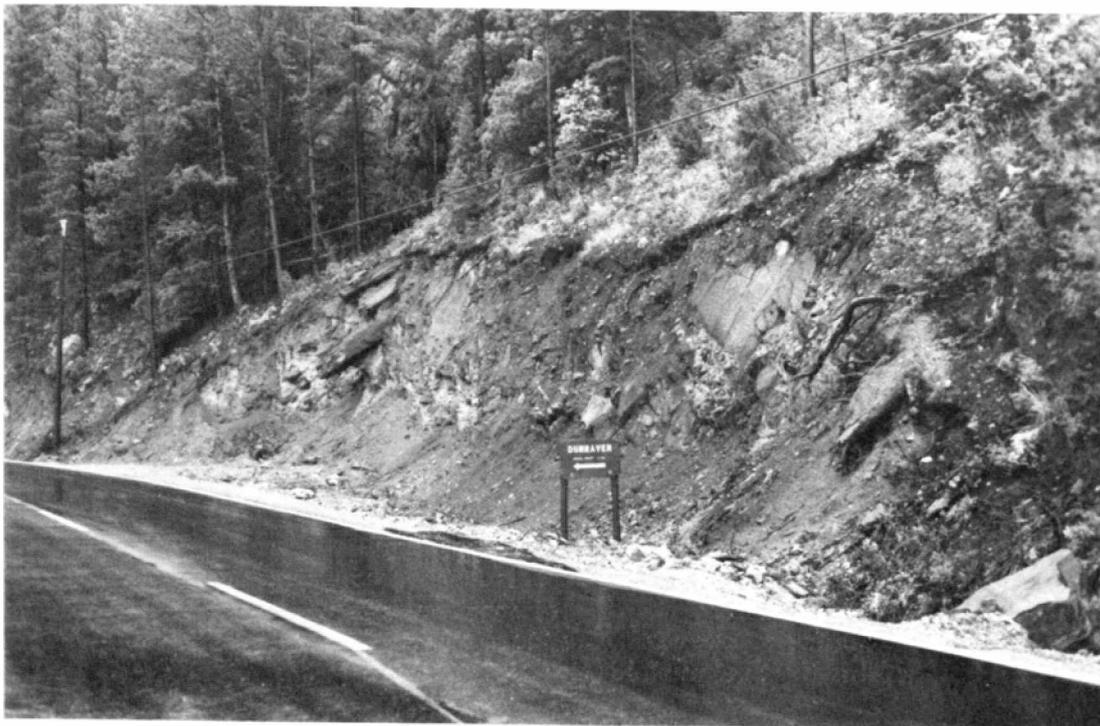
Figure 58, taken about one year after the flood, shows two slopes along the road approximately 6 miles upstream from Drake along the North

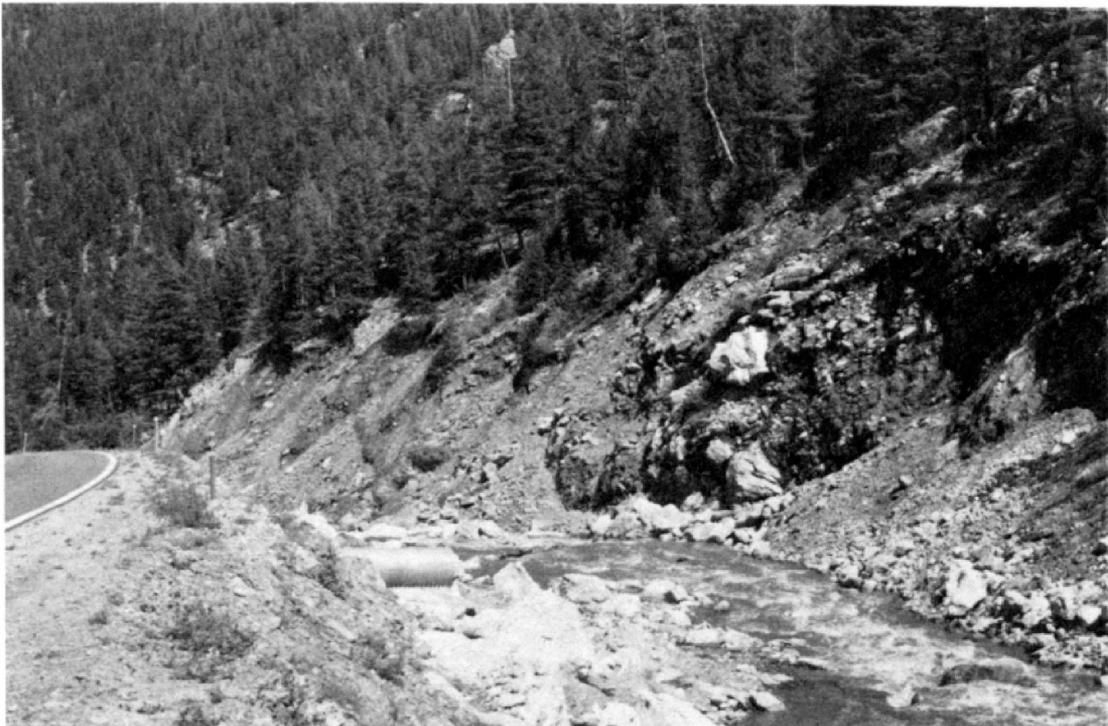
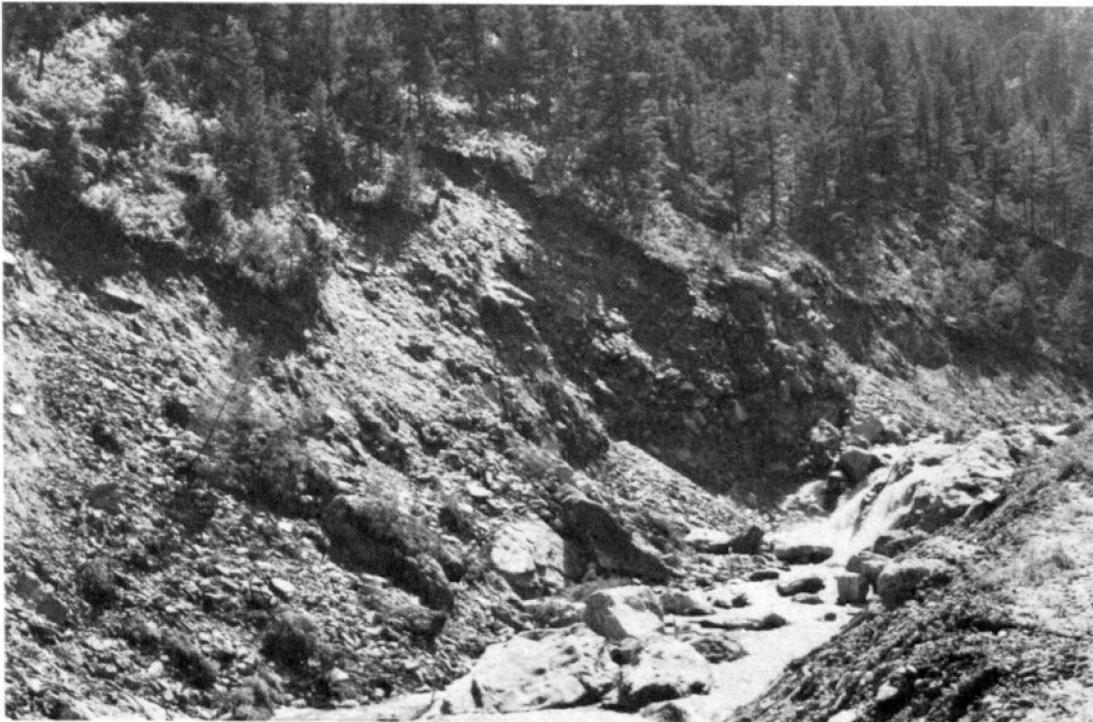
The soil and rock debris at the bottom of the slides was deposited sometime after the flood. River flows in the year after the flood have been abnormally low and the material at the toes of the slopes continues to accumulate. In subsequent periods of high flow this material may be

FIGURE 59 Slope Failure in Colluvium along Big Thompson River
Approximately 3 to 4 Miles west of Drake

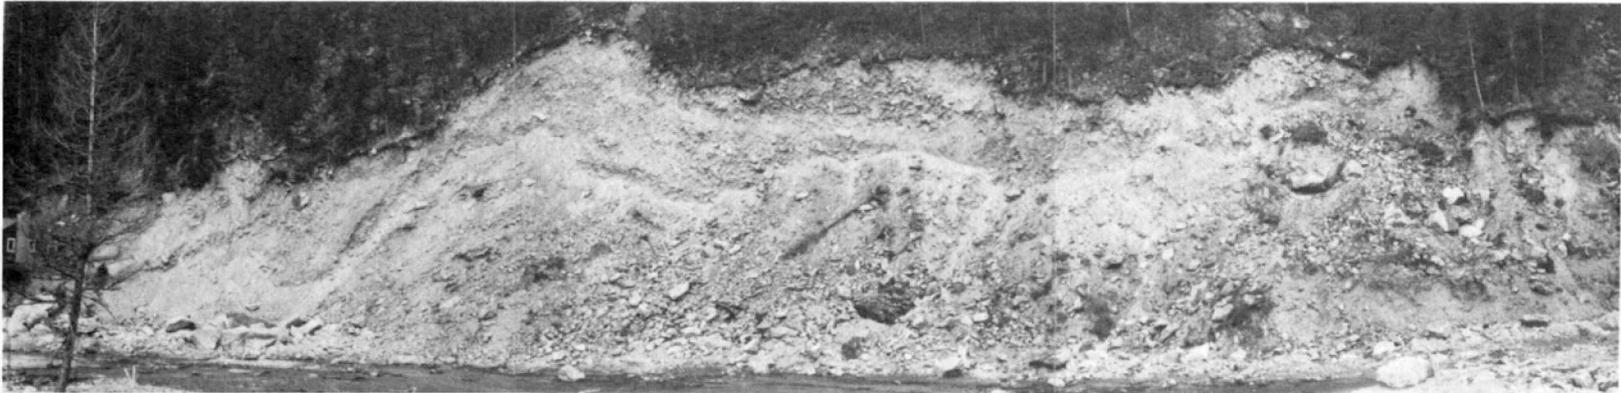
FIGURE 60 Slope Failure at Drake

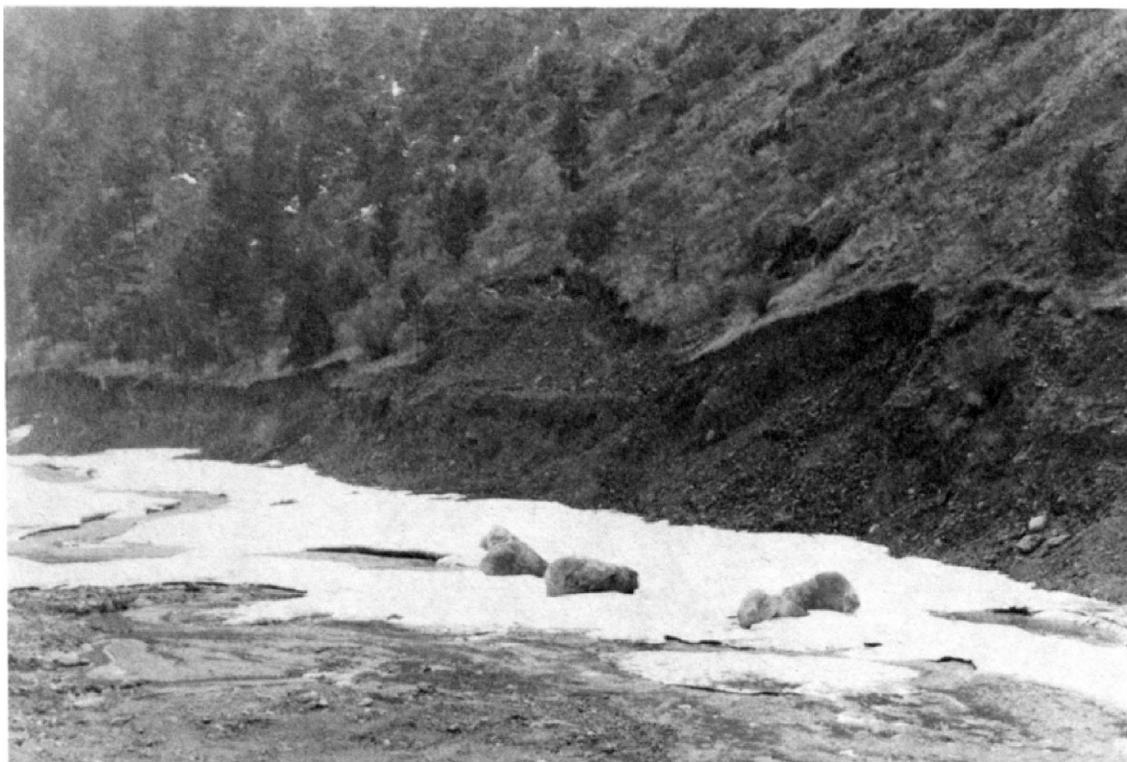
FIGURE 61 Slope Failure Formed about One Week after the Flood

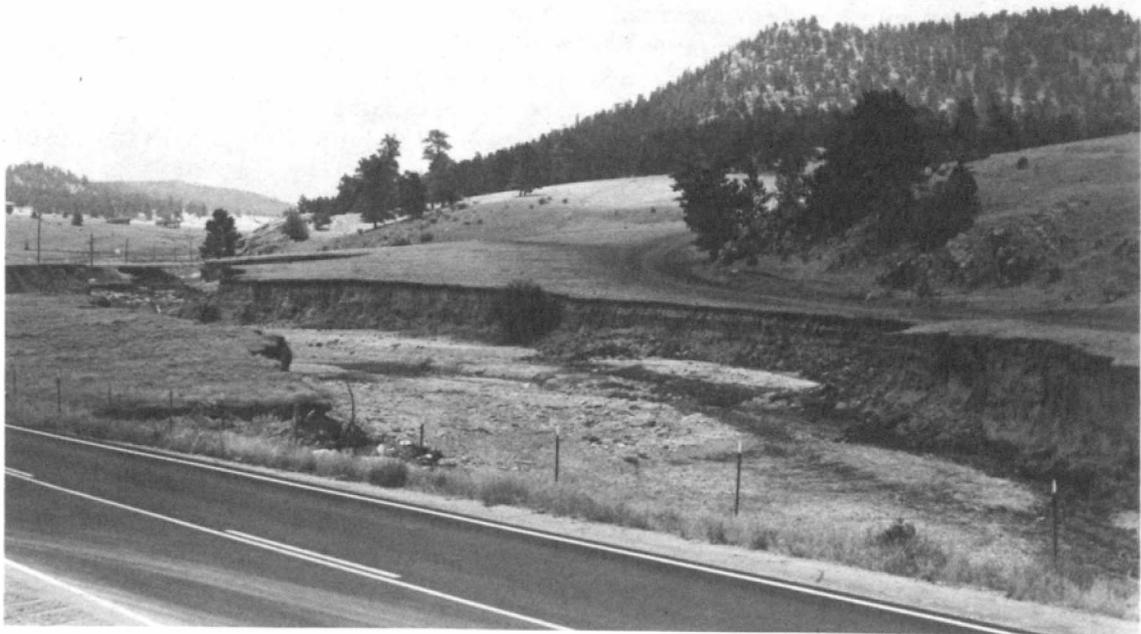
Another class of slope failure includes the erosion of debris fans where they existed in the floodplain. Figure 62 shows an area in Olympus Heights near Estes Park along Dry Gulch; the large amount of

FIGURE 62 Erosion along Dry Gulch

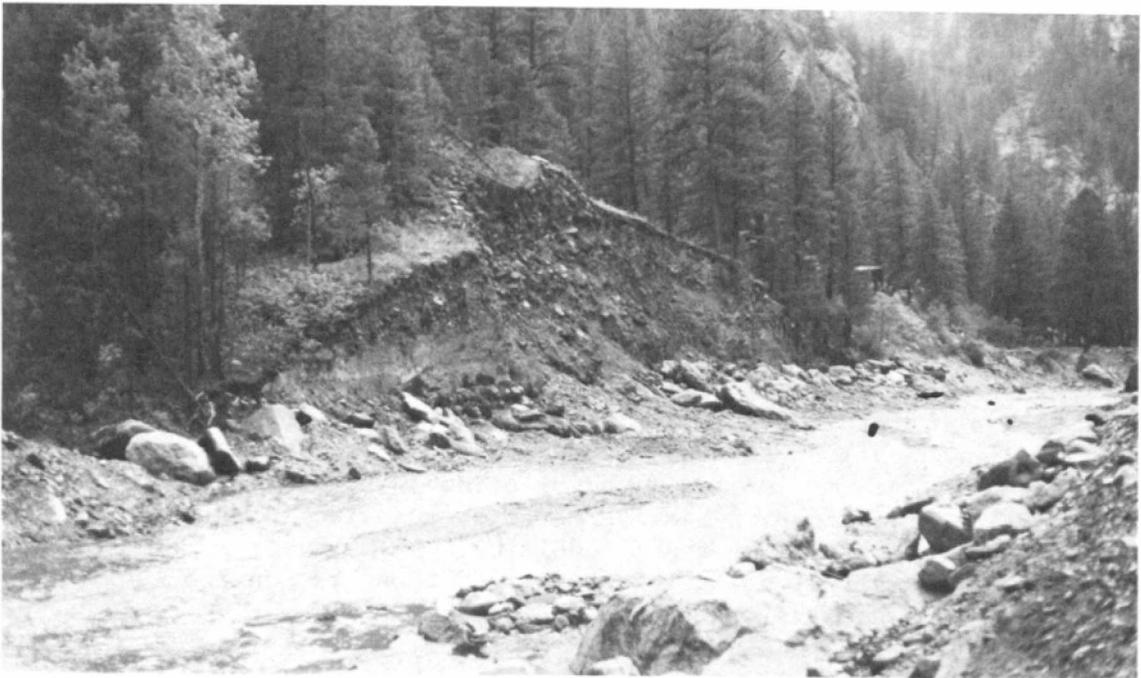
FIGURE 63 Erosion of Debris Fan

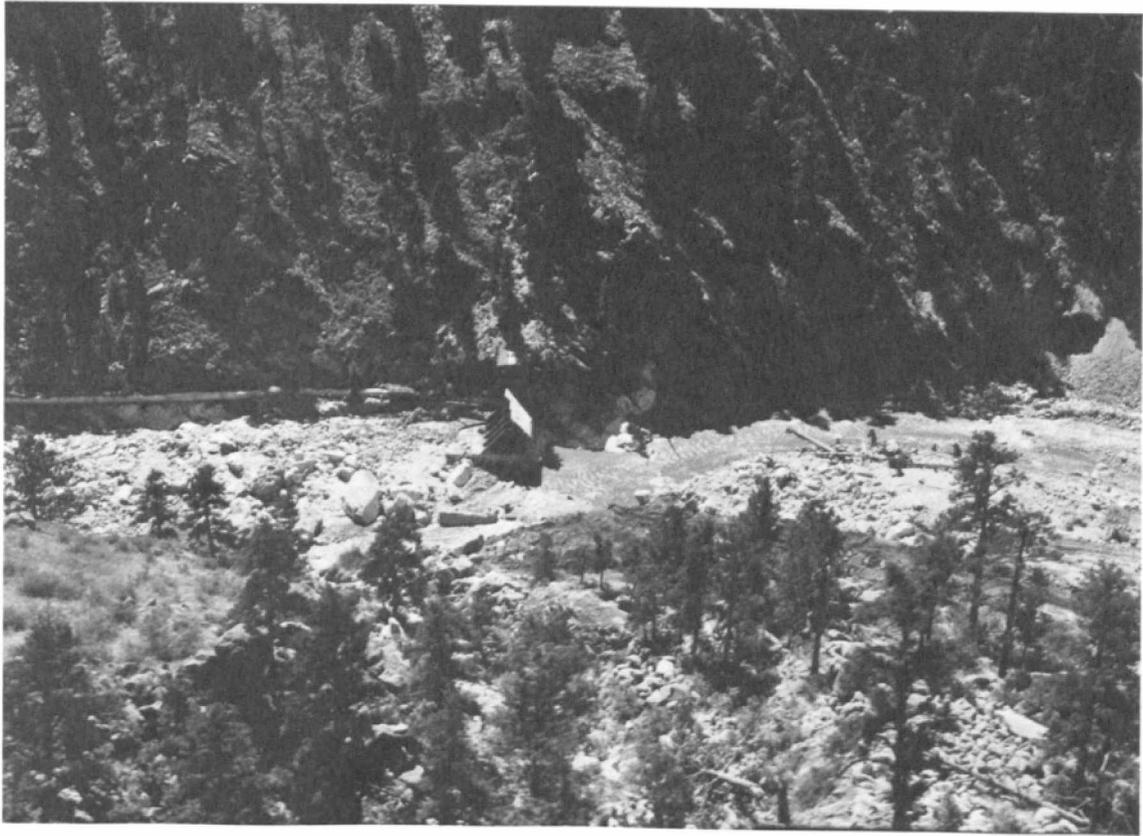
FIGURE 64 Remains of Loveland Hydroelectric Dam

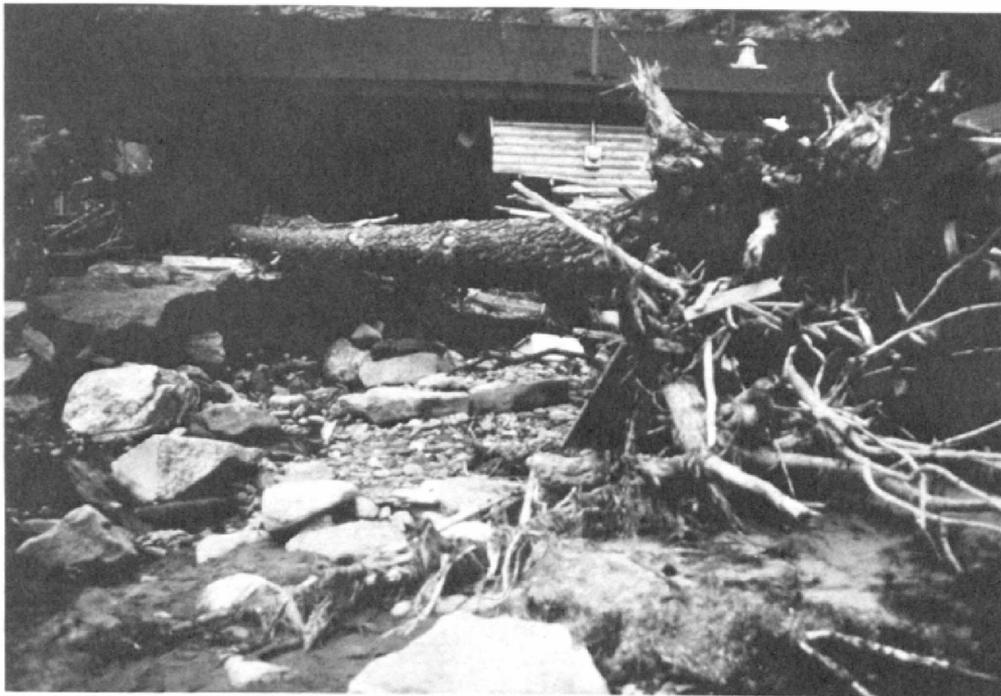
During the night of the Big Thompson flood almost 500 structures were damaged to some extent: 242 structures were damaged less than 50%, and 252 were damaged more than 50% (U.S. Corps of Engineers, 1976). Damage was mainly concentrated along the valley floor, although some damage to structures along higher ground were reported due to landslides, rock-falls, and other mass wasting processes. Destruction came mostly from battering by debris and materials moved by the stream. Figure 66 shows a house where the stream hurled a tree through the upstream wall.

FIGURE 66 House Damaged by Tree Hurlled through Upstream Wall

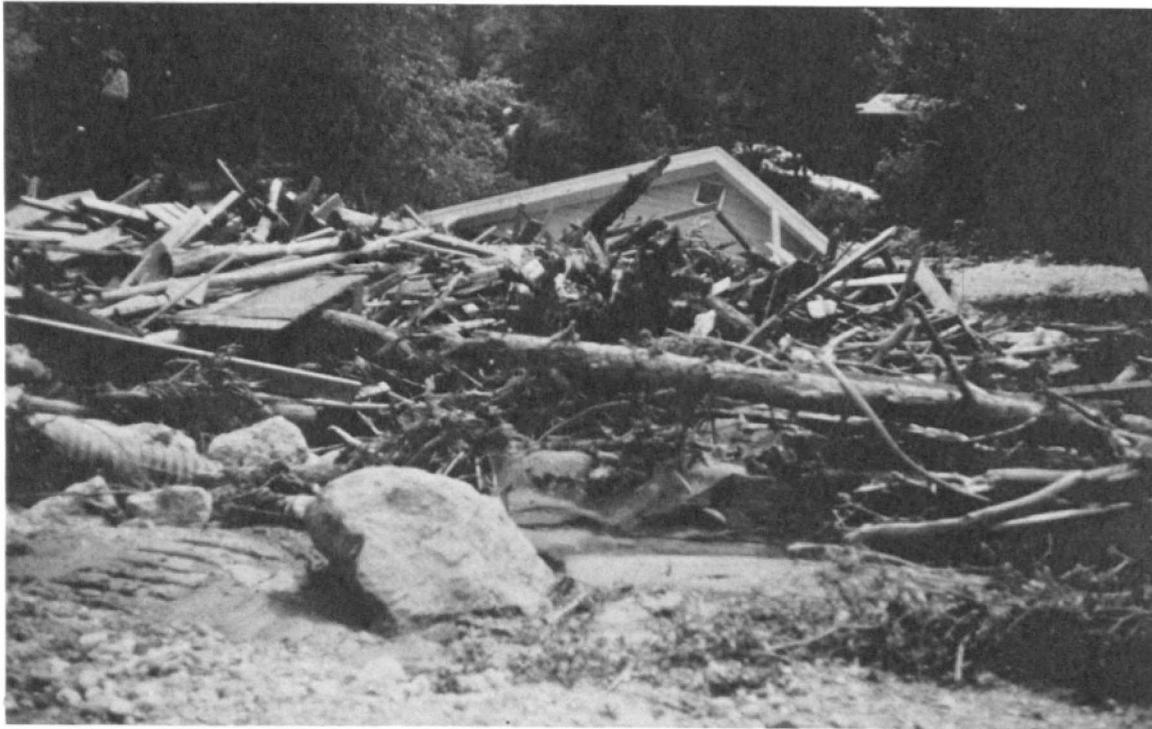
FIGURE 67 House near Drake Flattened by Boulders and Debris

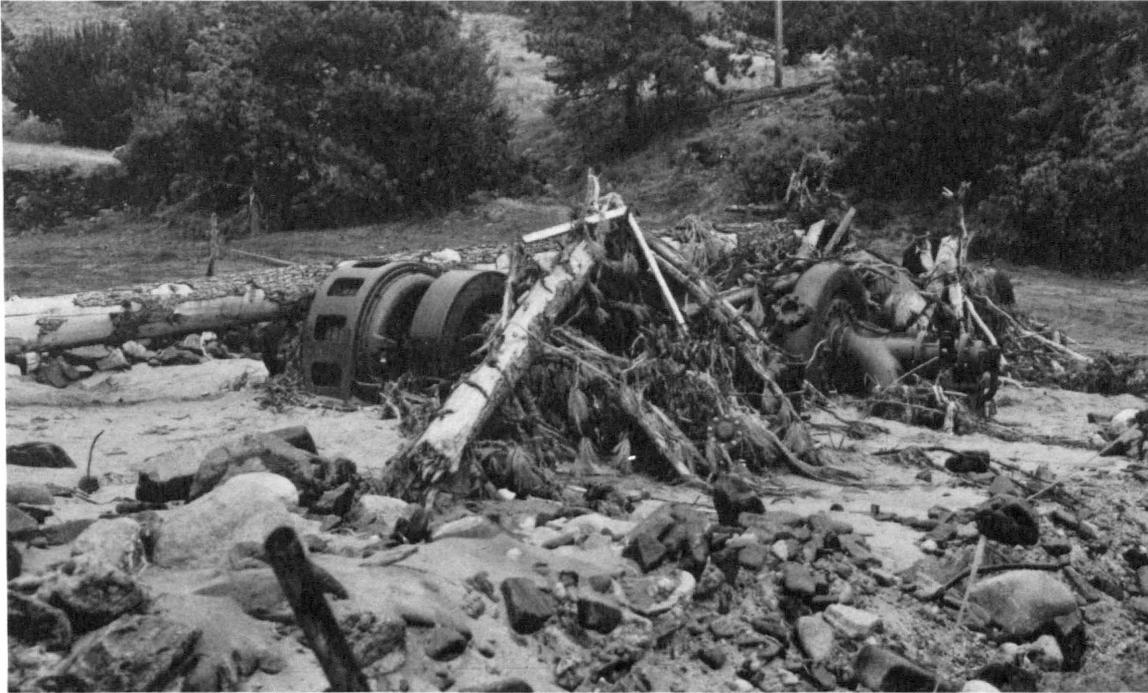
FIGURE 69 Remains of Loveland Power Plant at Loveland Mountain Park
