# BRIDGE DECK EXPANSION DEVICES

Herbert N. Swanson Colorado Department of Highways 4201 East Arkansas Avenue Denver, Colorado 80222

Interim Report September, 1983

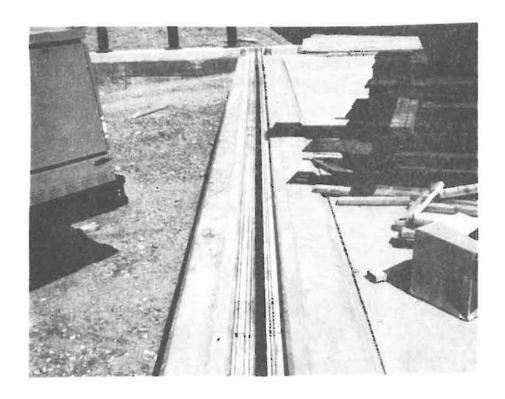
Photo #1 Delastiflex joint at Dotsero

The four Delastiflex joints placed on two structures near Dotsero were exceptionally good installations. The joints were placed and covered with a 1/8" fiber board prior to the paving of the final riding surfaces of the deck and approaches. This fiber board was worn off by traffic and gave good clearance for the entire joint.

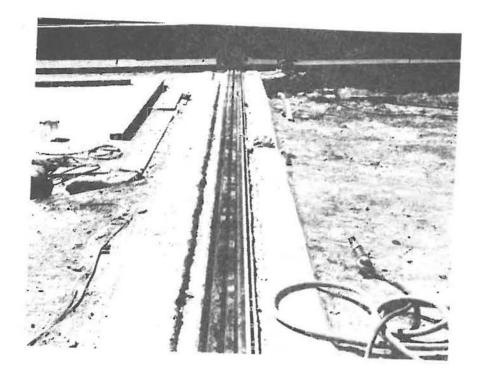
Photo #2

Delastiflex Expansion Device with Neoprene Installed.

W End Structure F-12-AL

The installation of the delastiflex expansion joint on I-70 over Corral Creek was accomplished without any problems. The finished approach, joint and structure were all on an even grade and had a good appearance.

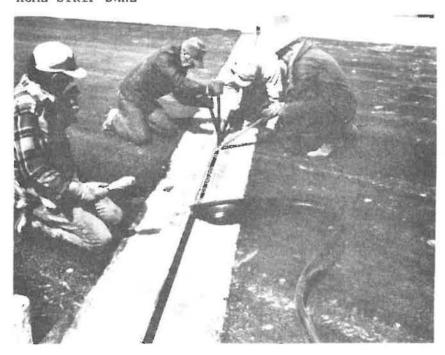
Photo 3

Acme Strip Seal

1-17-GU SH 83, 115 to B Street, Colorado Springs

Rubber extrusion being installed using screwdriver, steel bar and special tool.

There was some form slippage when the deck was poured on I-17-GU in Colorado Springs.

The "A" dimensions were within tolerances, but workmen had some difficulty installing the membrane. The final product was okay and looked good.

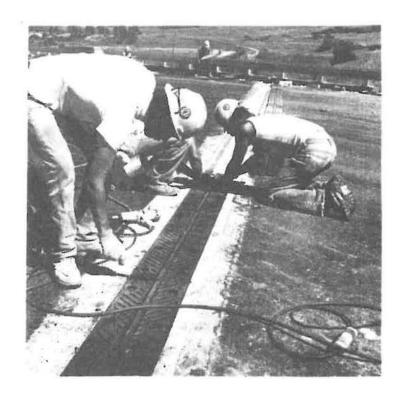
Photo 4

Workmen installing Fel Pro at I-25 over Perry Park Road.

The placement of Fel-Pro was completed with no major problems. The expansion joint was completed at or very near the finished grade and appeared to be okay at the completion of the project.

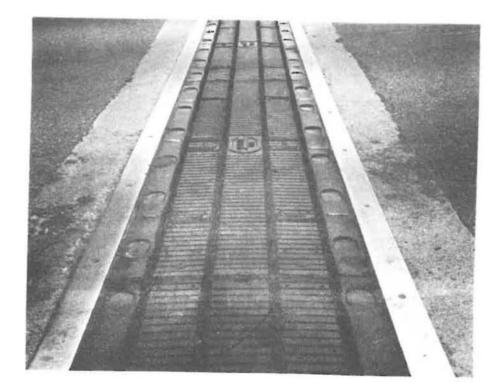
Photo 5
Transflex 400A on 1-70 Viaduct.

Both sizes of Transflex looked good just after installation, however, the surface was flushed with the finished grade.

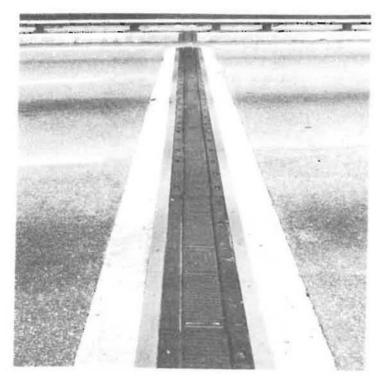
Photo 6

Transflex 250 on 1-70 Viaduct

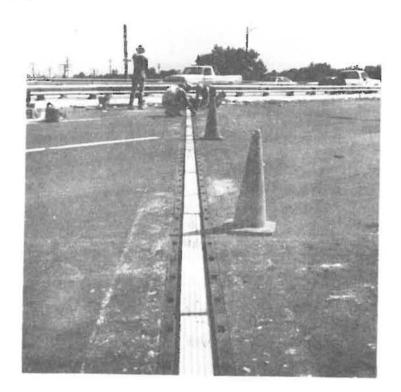
# Photo 7

Waboflex SR2A on 1-70 Viaduct.

This joint was also finished at the same grade as the finished roadway. Installation went well and the joint looked okay.

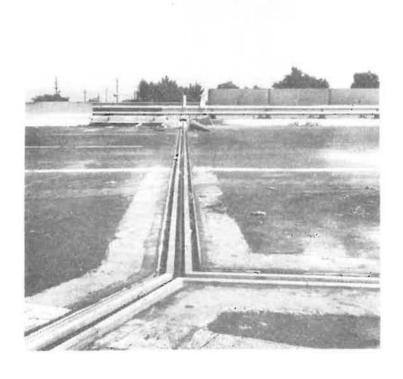
# Photo 8

Onflex was placed on several joints on the 46th Avenue Viaduct.

Special Y joints were constructed to accommodate adjoining structures at ramps and railroad overpasses.

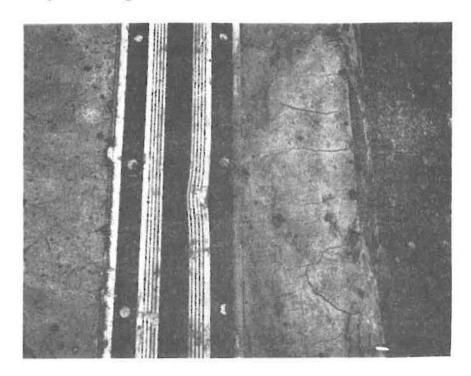
Photo 9

The center of the aluminum was damaged by equipment during the installation of Onflex 45 at Durango. There was also a variation of 3/16" in the 'A' dimension across the length of the joint. There has been no subsequent damage and this is not believed to be the cause of subsequent leaks.

Aluminum damaged on this Onflex expansion joint device at Durango.

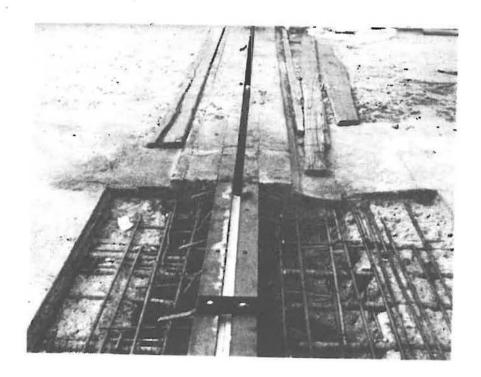
Photo 10

I-70 Viaduct WB Experimental Joint #39

Neoprene Compression joint seal. A metal channel and bolts are used to maintain the proper "A" dimension.

An epoxy glue serves as a lubricant while the neoprene sealer is forced into place. The contractor encountered no problems with most of these joints on the 46th Avenue Viaduct. The metal angle iron parts were installed too close together on three joints and a special order for smaller neoprene strips was made.

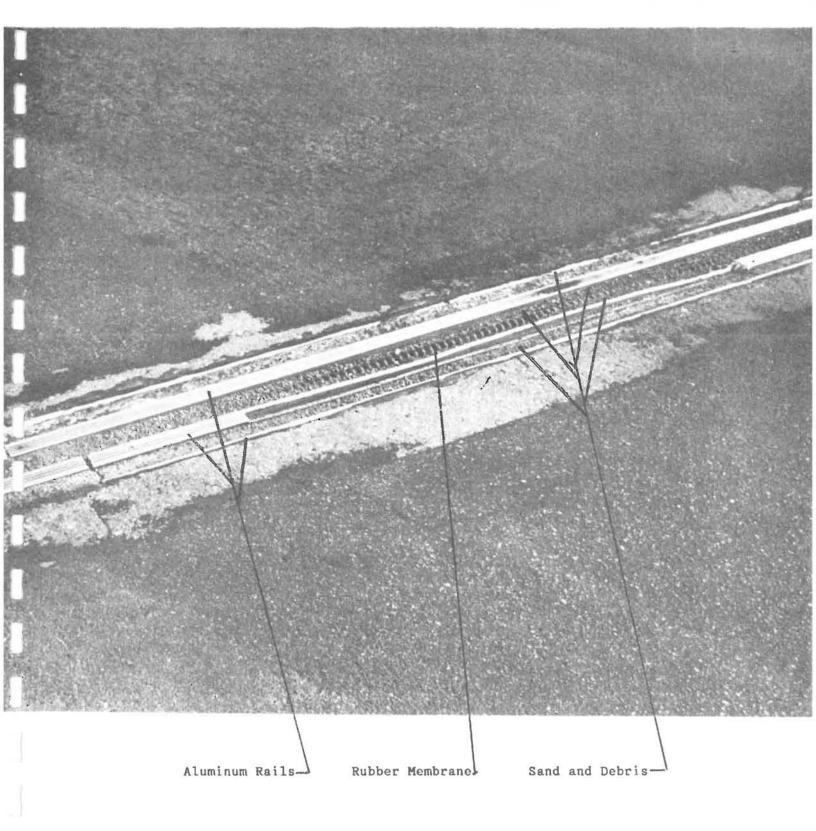
Photo #2, snowplow damage to the aluminum rail of an Onflex 45 joint number 8 on the westbound 46th Avenue Viaduct. This joint now has major leaks during wet weather.

The sand and debris is typical in all recessed parts of all of the experimental expansion joints.
