FLOOD OF 31 JULY 1976
IN
BIG THOMPSON CANYON, COLORADO

D. B. Simons, J. D. Nelson, E. R. Reiter, and R. L. Barkau

Committee on Natural Disasters
Commission on Sociotechnical Systems
NATIONAL RESEARCH COUNCIL

National Academy of Sciences
Washington, D.C.
1978

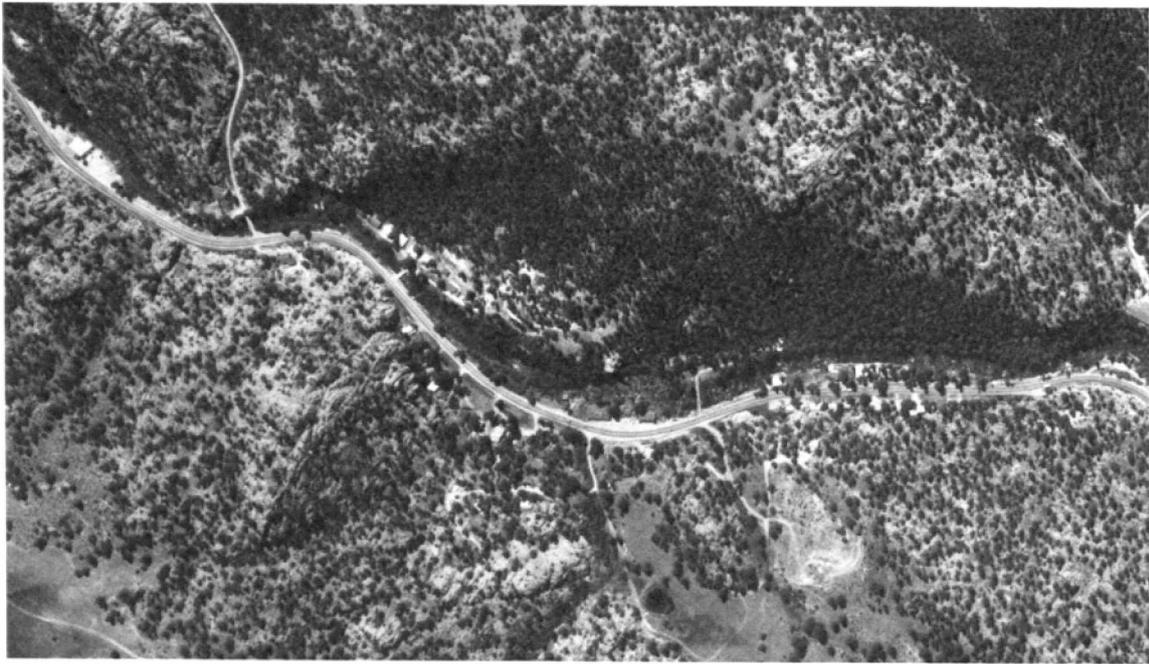
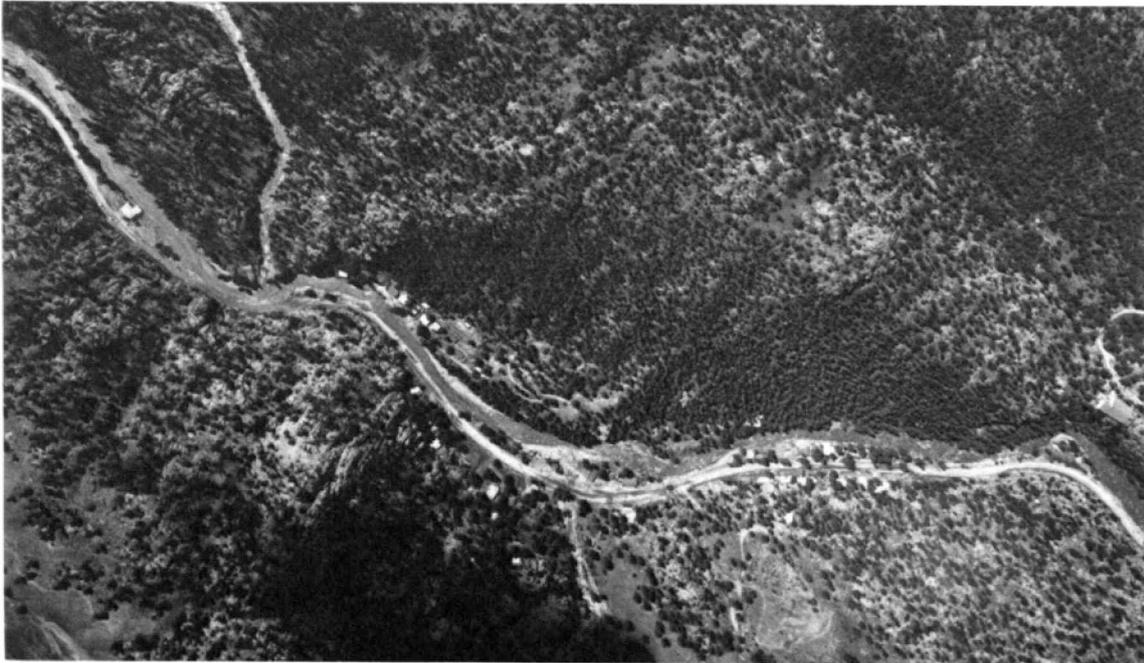
FIGURE 22 Small Tributaries Entering the Big Thompson River near Glen Comfort, before and after the Flood

BT-1:--Reach BT-1 is characterized by sheet erosion, severe scour along tributaries, and deposition along the main stem. This area received the most intense rainfall and had the largest area of sheet erosion in the northern part of the reach. Overland flow concentrated rapidly, causing large discharges and very high velocities in tributaries. The average slope of tributaries exceeded 450 feet per mile and the average velocities were greater than 20 feet per second. The high velocities eroded 6 to 10 feet of material and, in some cases, eroded the channel down to bedrock. Near the mouths of the tributaries where stream gradients decrease as flow enters the main stem, large amounts of materials were deposited in debris fans. Often these fans infringed on property and caused severe damage, This is particularly true near Glen Comfort where

the debris from Dark Gulch covered part of the town. Figure 22 shows before and after aerial photographs of the area around Glen Comfort. Note the intense scour along Dark Gulch and the manner in which the debris fan covered the town.

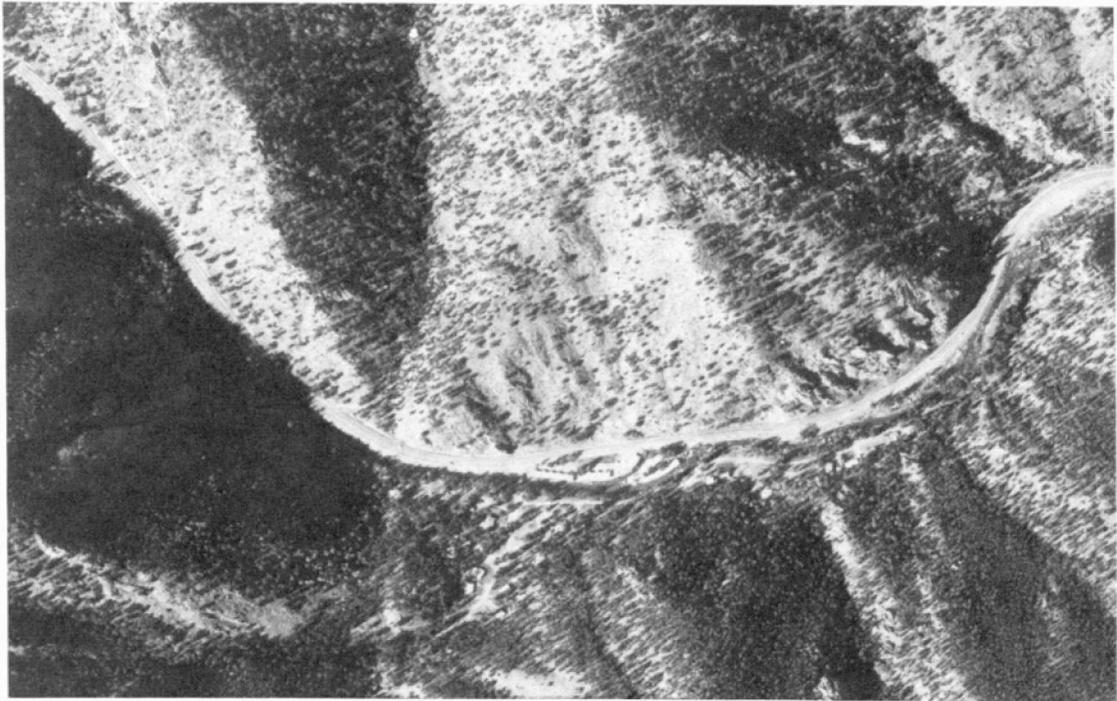
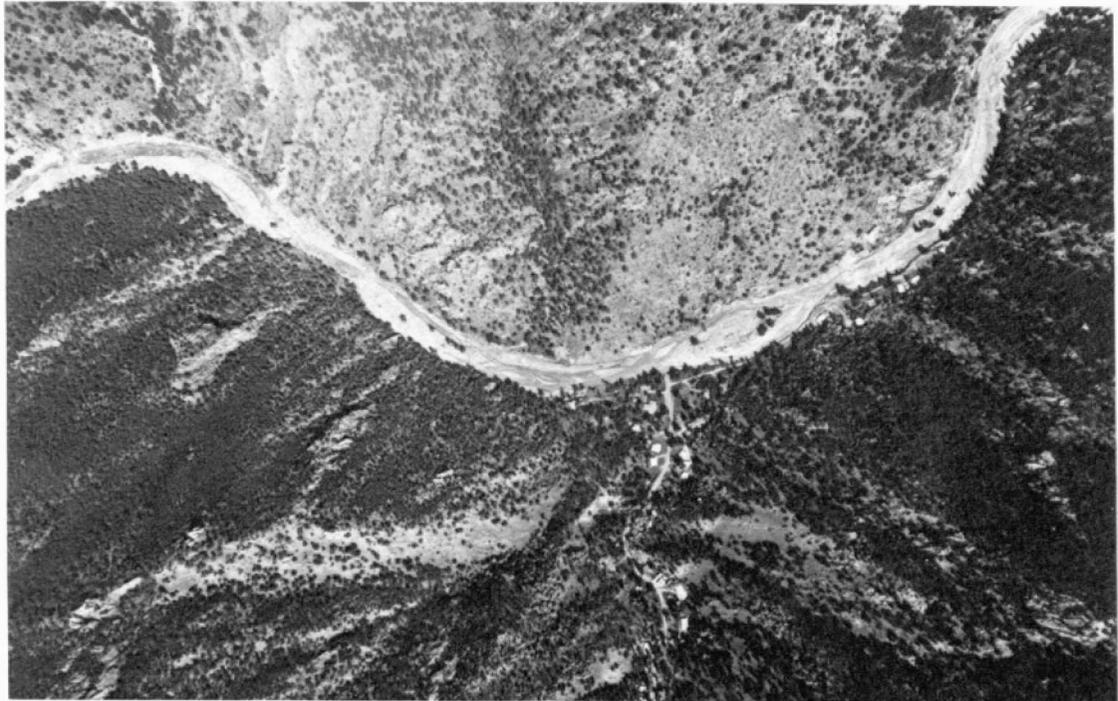
FIGURE 24 Waltonia Area

Just upstream of Waltonia the valley widens to about 200 feet, resulting in a reduction of stream competence even though stream gradient changed little. Materials scoured from upstream overloaded flow and caused extensive deposition. Channel braiding can be seen immediately above Waltonia (Figure 24, after). Near Waltonia the original channel was clogged by deposited materials, forcing a shift in the channel to the north slope of the valley, eroding the highway.

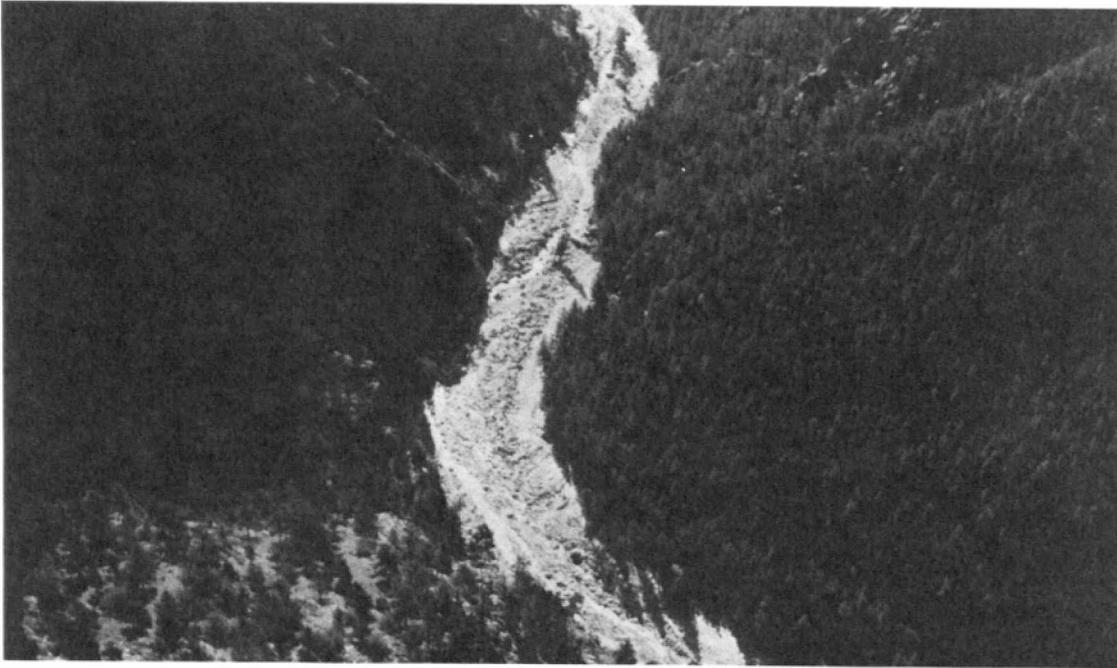
FIGURE 25 Scour on the Upstream Reach from Drake

Downstream toward Drake the valley narrowed, resulting in moderate to severe scour. Stream competence probably included boulder sizes. Figure 25 shows a length of this stream just above Drake. Note that the highway is completely gone. Just above Drake at site 12, a discharge of 28,200 cfs and a velocity of 22 fps was estimated, illustrating the predominantly high velocities along this reach.

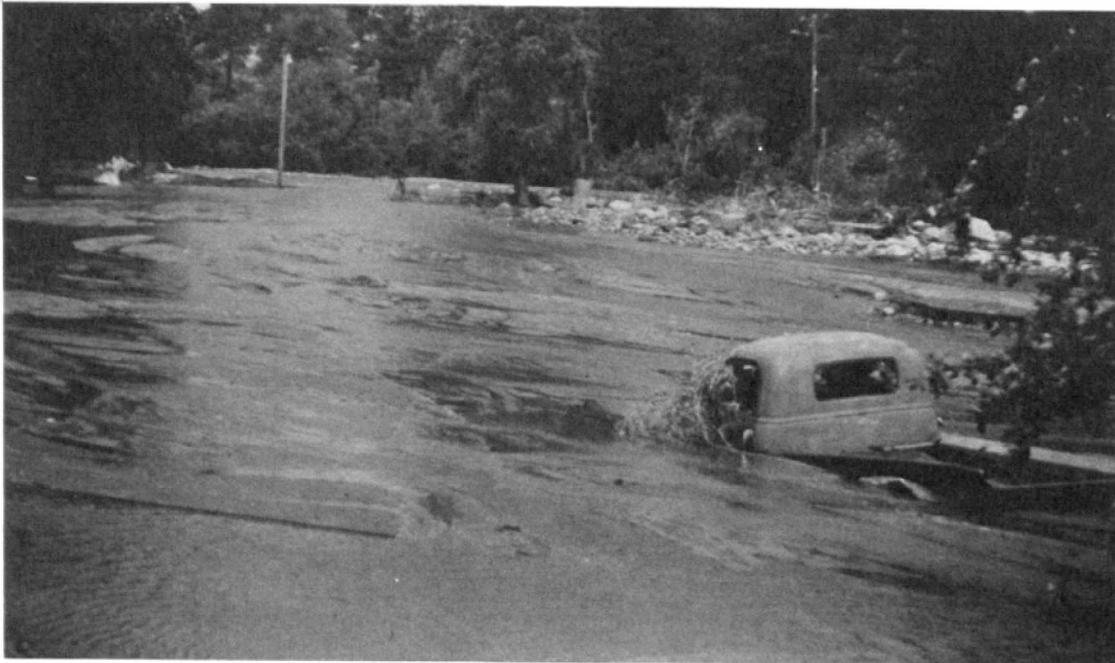
FIGURE 26 Sediment Deposited in the Glen Haven Area

NF-1:--This reach is characterized by heavy deposition around Glen Haven. Much of this material came from Devils Gulch to the south, which showed signs of severe scour. Aerial photographs showed little activity from the North Fork, Fox Creek, or West Creek, west of Glen Haven. Figure 26 provides an idea of the depth of sediment which was deposited at Glen Haven.

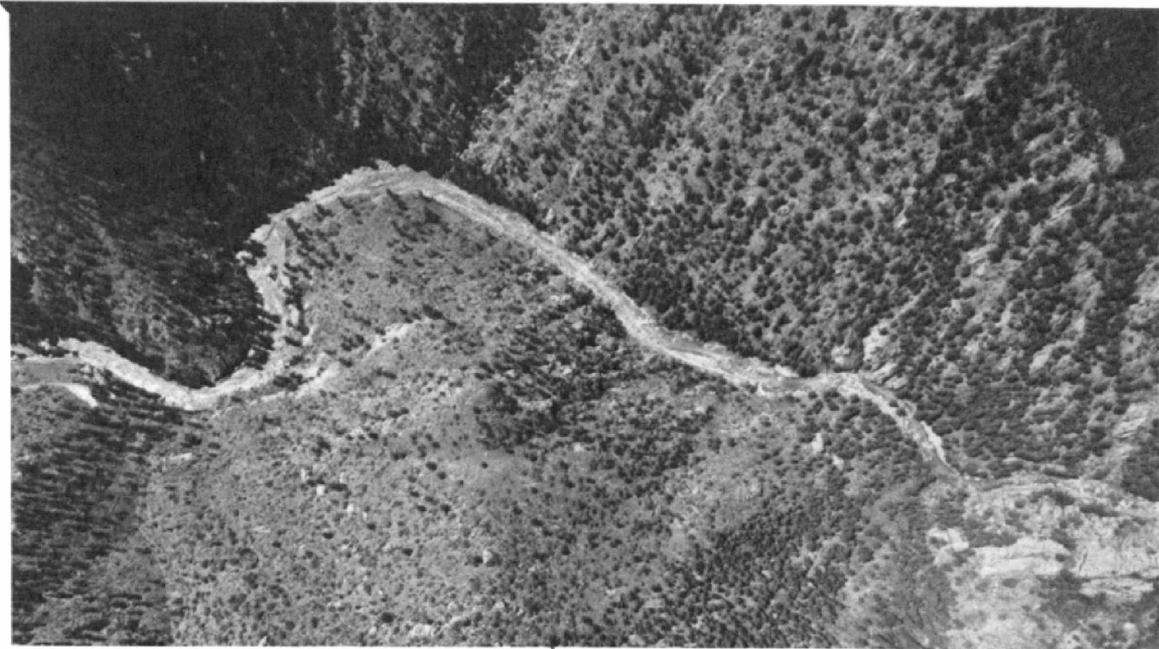
FIGURE 27 Scour along the North Fork

NF-4:--Along this reach the gradient again increases to about 200 feet per mile, and the valley width decreases to about 100 feet. This reach experienced severe scour with stream competence including boulder sizes. Figure 27 shows a length of this reach. Note that the roadway which had paralleled the river was eroded away.

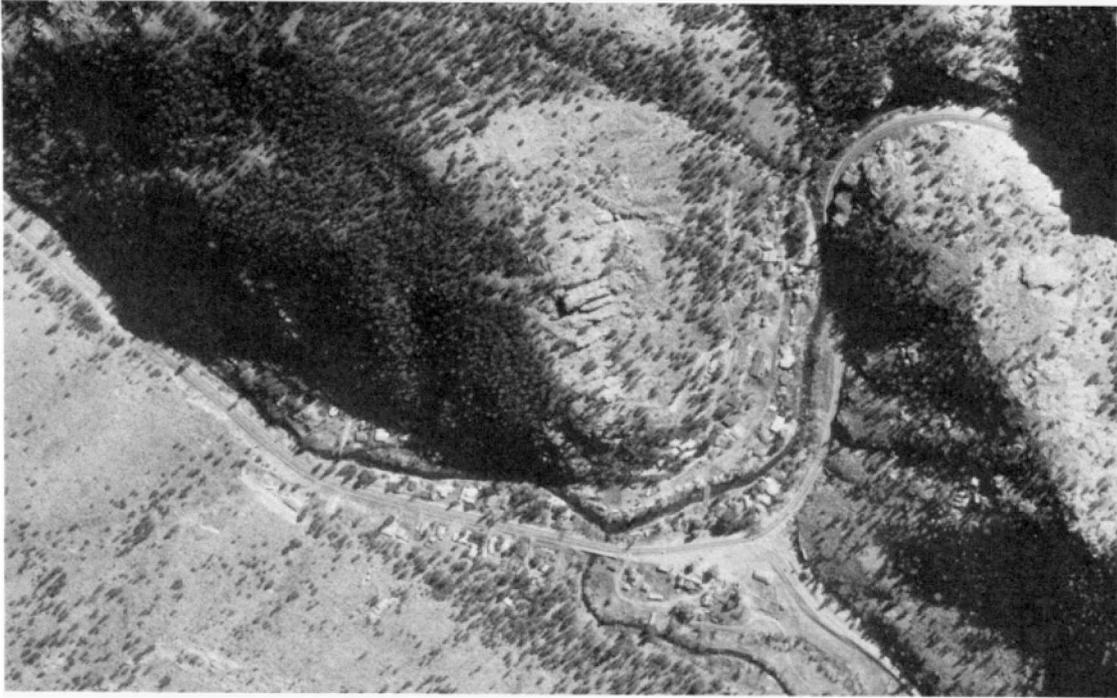
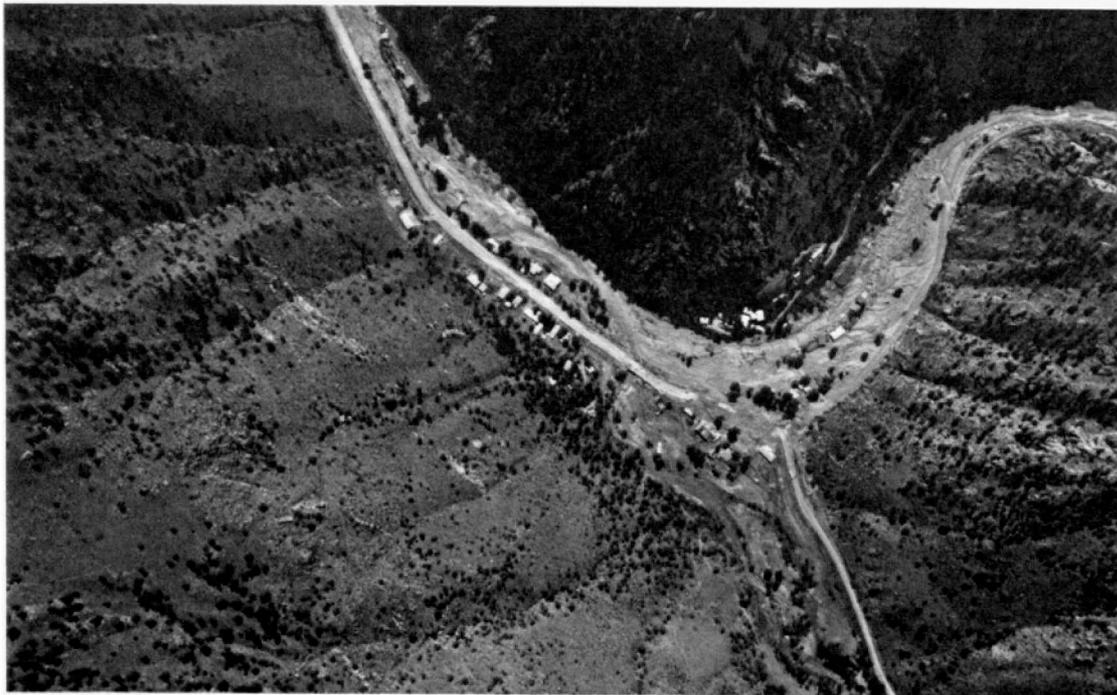
FIGURE 30 Drake

change in gradation in the downstream direction. Figure 30 shows aerial photographs before and after the flood event. These changes are very marked. Below Drake the velocity of the Big Thompson river was estimated to be 16 fps at site 22, indicating a change in velocity caused by the widening of the channel.

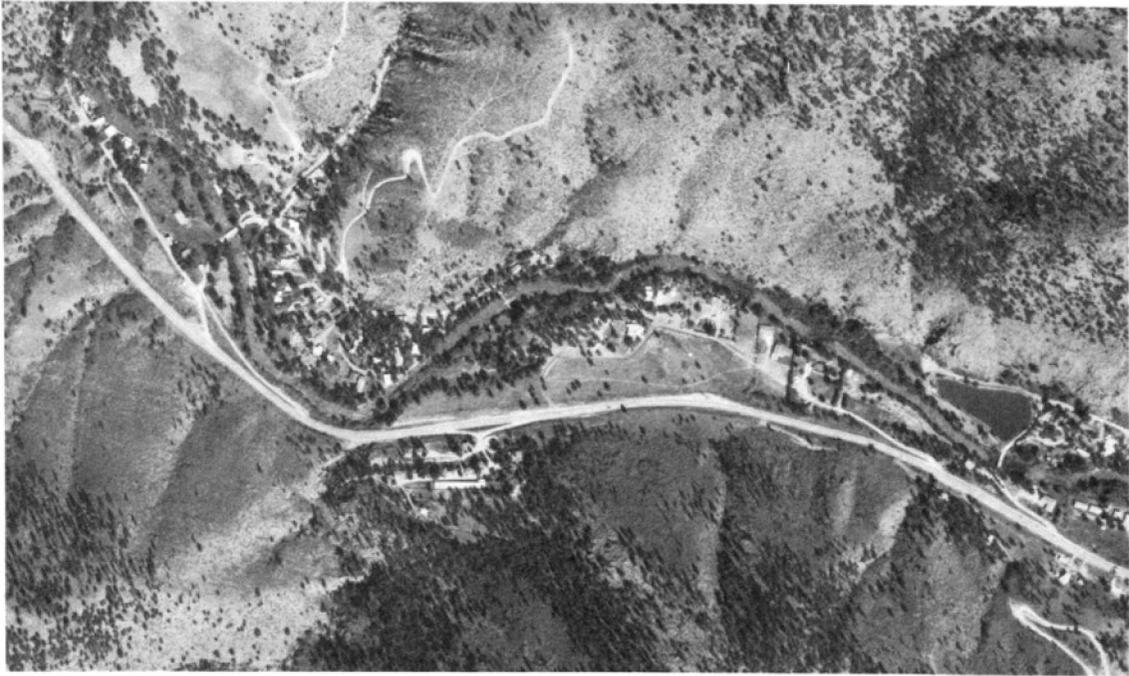
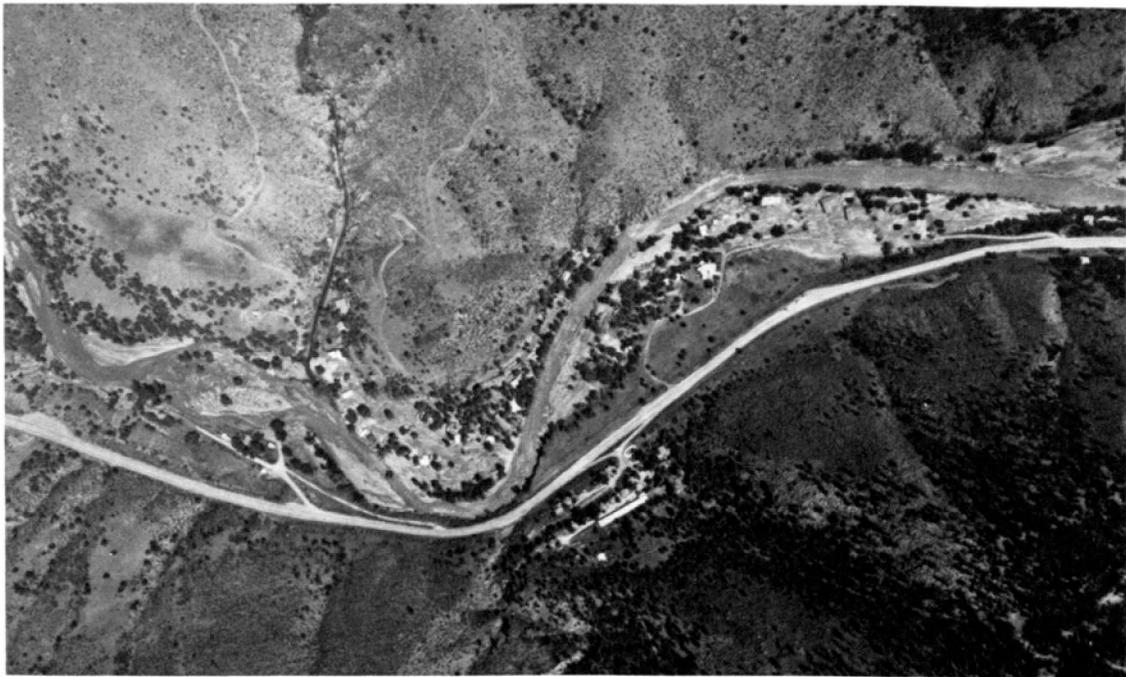
FIGURE 32 Deposits near Cedar Grove

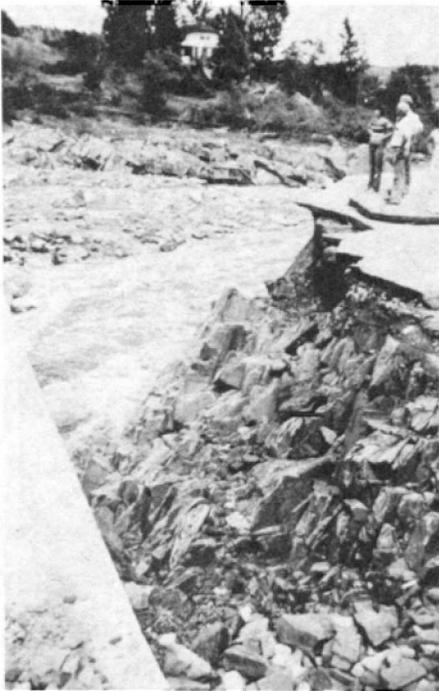
Another type of failure occurred by the erosion of backfill material around bridge abutments. This can be seen in Figure 40 where the abutment was left standing and the approaches were washed out. This type of failure was not restricted to the Big Thompson Canyon. Heavy rains and flooding in the entire area washed out bridge approaches at several locations in neighboring areas. Consequently, several roads in the surrounding area were closed for as long as several days. The impact of those road closures on the disaster area, however, was not large and transportation in and out of Loveland was not severely hampered.

FIGURE 40 Erosion of Backfill Material
at Bridge Abutment

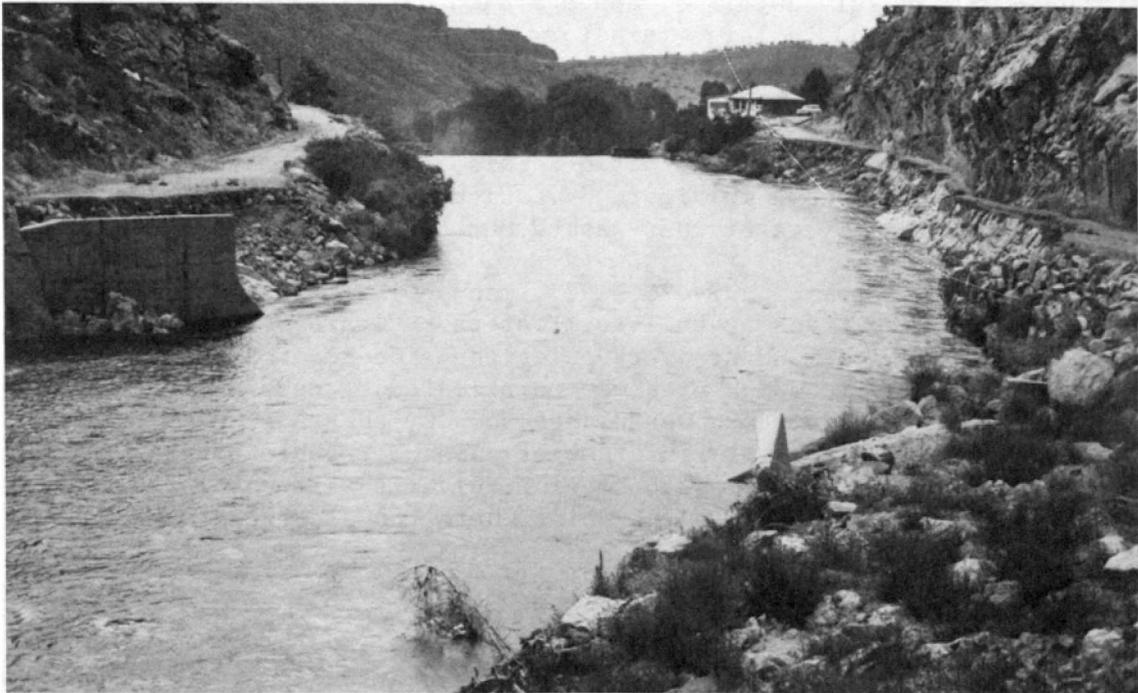
Another example of the failure of a bridge abutment is shown in Figures 41 and 42. Figure 41 shows the river just upstream from the dam near the Loveland Filtration Plant. A steel truss bridge crossed the river between the abutments. Scour of the backfill material at the approaches is evident. However, the force of the water behind the abutment and on the bridge pushed the right abutment inward, as can be seen in Figure 42.

FIGURE 41 Abutments of Destroyed Bridge near Loveland Filtration Plant

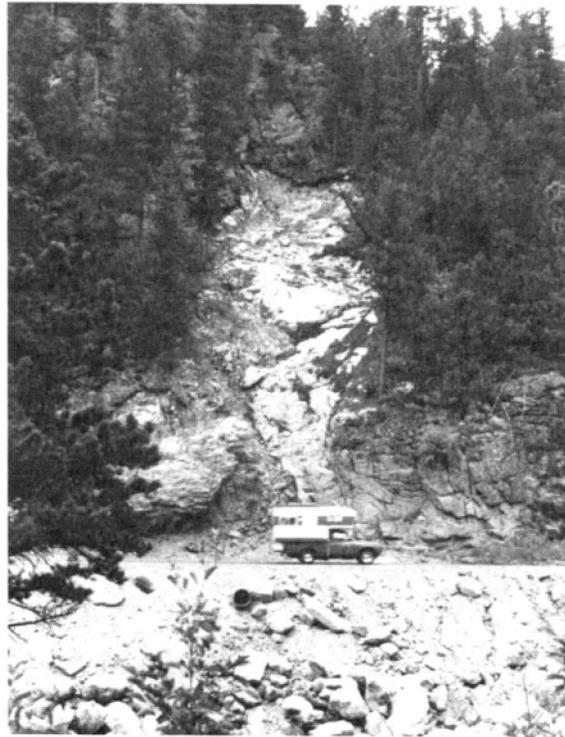
FIGURE 57 Landslide in Residual Soil

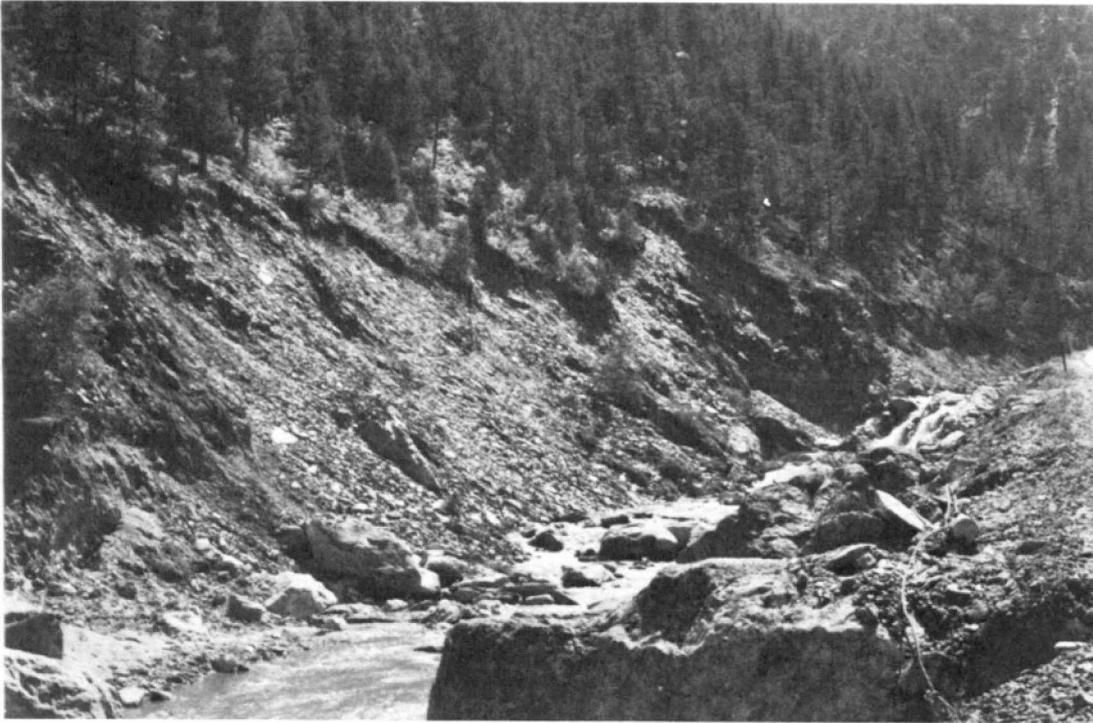
(b)

Figures 59a, b, and c show an area, about one mile long, about 3 to 4 miles upstream from Drake in the Big Thompson canyon. A large slope failure also occurred near Glen Comfort. Figure 60 is a composite photograph showing most of the length of that failure.

In the above slide areas the soil was thick and failures appear to have been induced by erosion along the streambank. Comparison of photographs taken in March 1977 and June 1977 indicate that sloughing is continuing on these slopes. The upper root zone of soil is clearly evident in Figures 59 and 60. The upper soil cover is continuing to slough off exposing more of the upper part of the remaining slope. It is expected that movement of the slope will continue for a considerable time after the flood.

FIGURE 59 Slope Failure in Colluvium along Big Thompson River
Approximately 3 to 4 Miles west of Drake

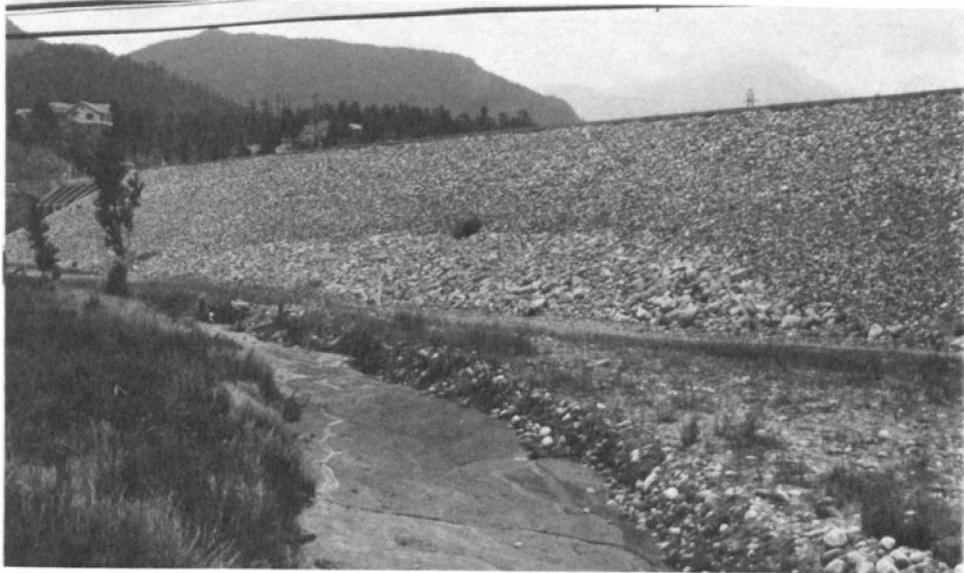
One potentially drastic occurrence is illustrated in Figure 65, showing the Olympus dam in Estes Park. The light colored zone of rock at the toe of the dam was eroded by the floodwaters flowing down Dry Gulch in the foreground of the photograph. Olympus dam is 47 feet high and is located a short distance above the mouth of the Big Thompson canyon in Estes Park. If that dam had failed the effects of the flood would have been much worse.

FIGURE 65 Olympus Dam

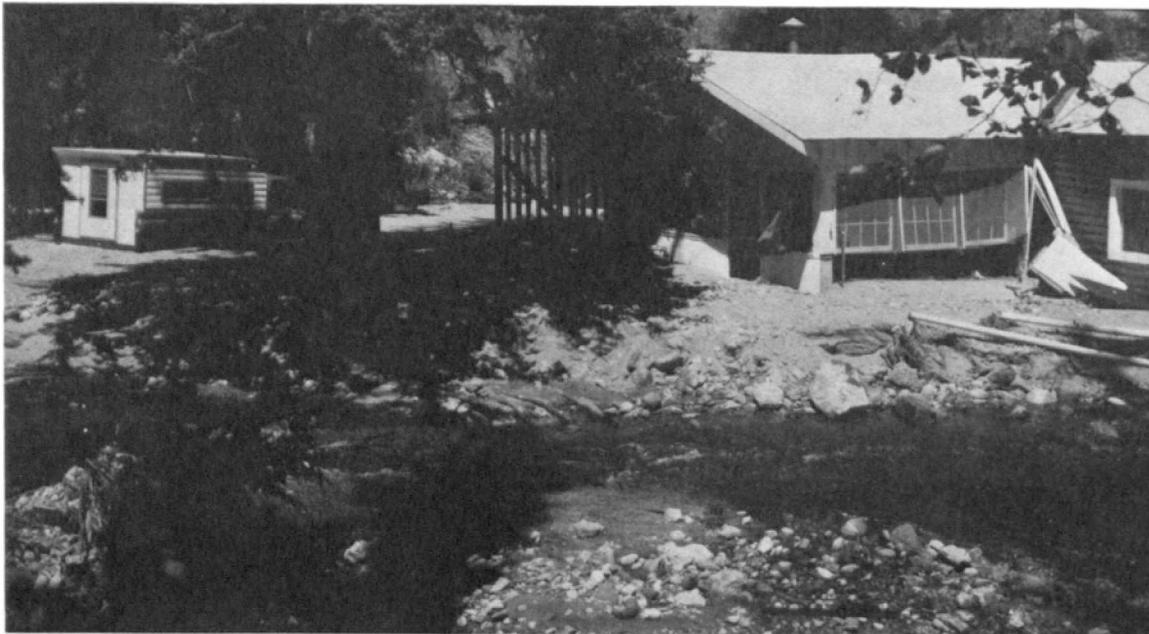
FIGURE 68 Sediment Deposited around House along West Creek

Figure 67 shows a house near Drake that was flattened by boulders and debris. Other damages resulted from structures being buried by sediment (Figure 68). Floodwaters demolished the Loveland Diversion Dam and Power Plant (Figures 48, 64, and 69). Damage to these structures was estimated to be \$2,500,000. The masonry structure which protected the Loveland Power Plant completely disappeared--carried away by floodwaters --leaving only the exposed turbines. One of the more unusual structures to be damaged was the U.S. Bureau of Reclamation siphon which carried the Charles B. Hanson Canal across the canyon. That night a floating structure hit and pushed out a pier supporting the siphon, causing it to collapse under its own weight. Figure 70 shows the canyon opening minus the siphon and Figure 71 shows the battered siphon deposited downstream. Repair costs for the siphon were approximately \$300,000.

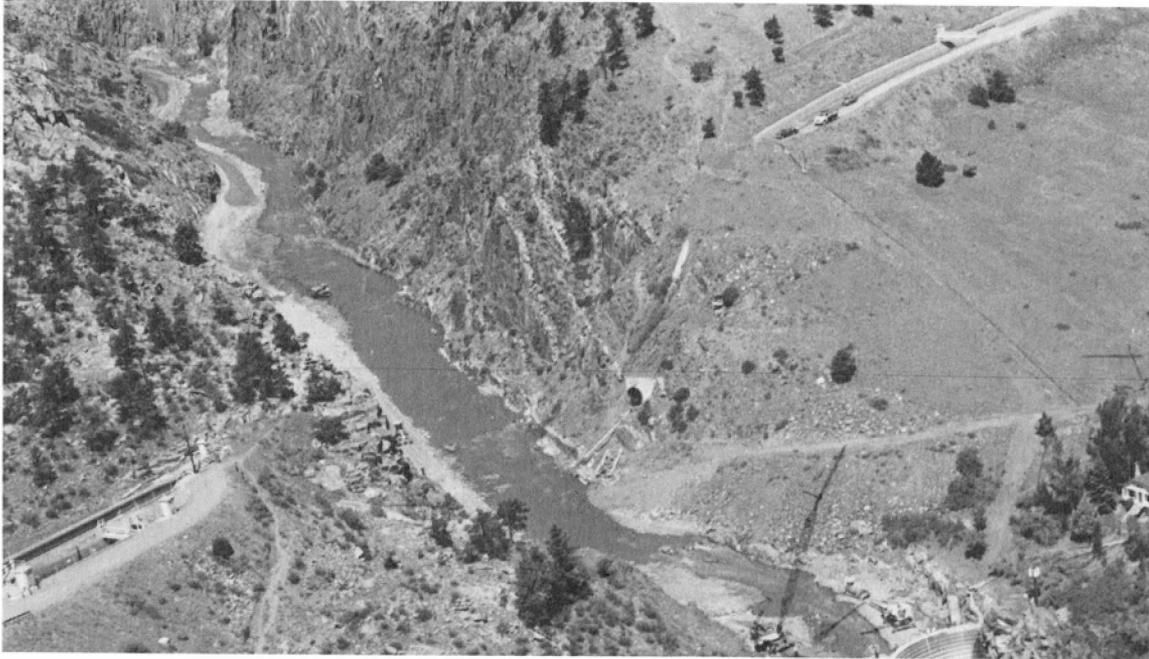
FIGURE 70 Siphon Support Structure and Feeder Canal
Located at the Mouth of the Canyon

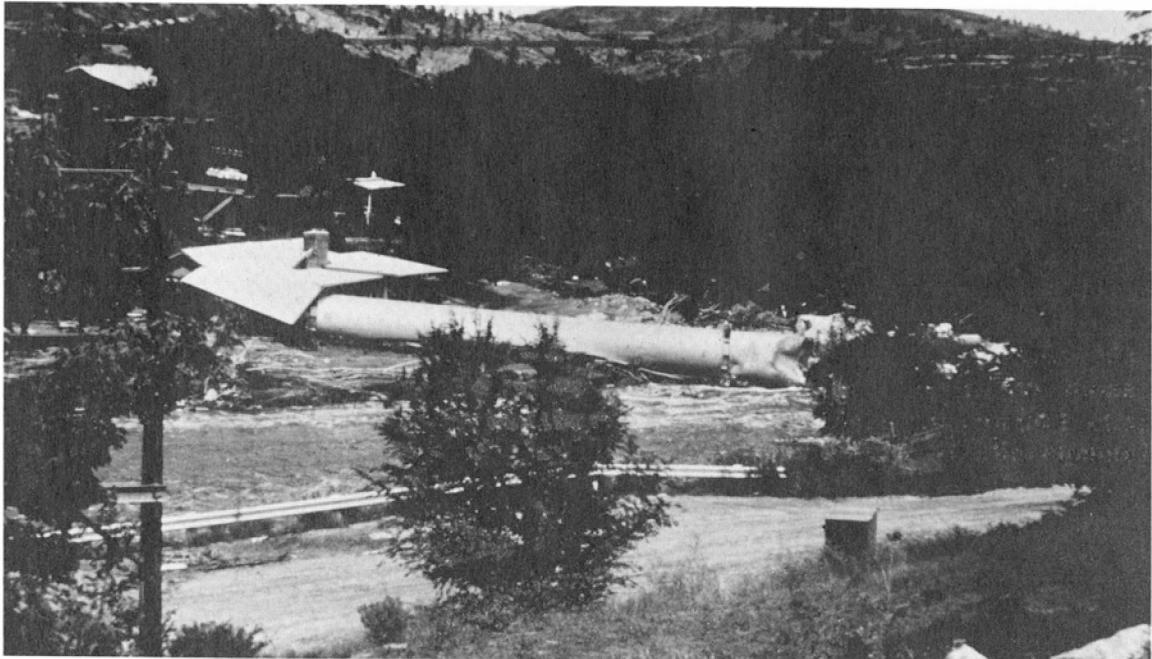
FIGURE 71 Remains of the U.S. Bureau of Reclamation Siphon
