# BRIDGE DECK EXPANSION DEVICES

Herbert N. Swanson Colorado Department of Highways 4201 East Arkansas Avenue Denver, Colorado 80222

Interim Report September, 1983

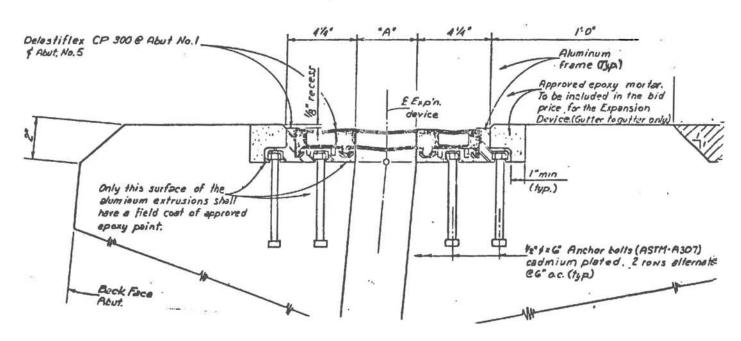
Diagram A

The installation of the delastiflex expansion joint on I-70 over Corral Creek was accomplished without any problems. The finished approach, joint and structure were all on an even grade and had a good appearance.

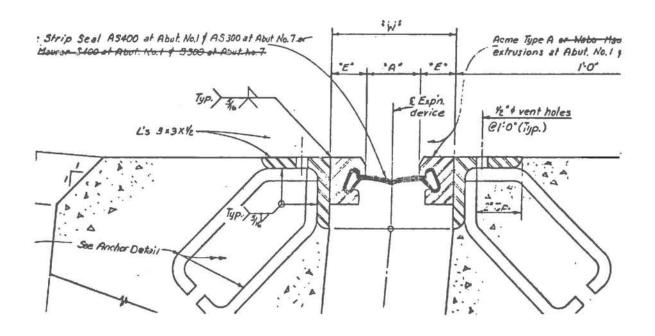
Diagram B

There was some form slippage when the deck was poured on I-17-GU in Colorado Springs.

The "A" dimensions were within tolerances, but workmen had some difficulty installing the membrane. The final product was okay and looked good.

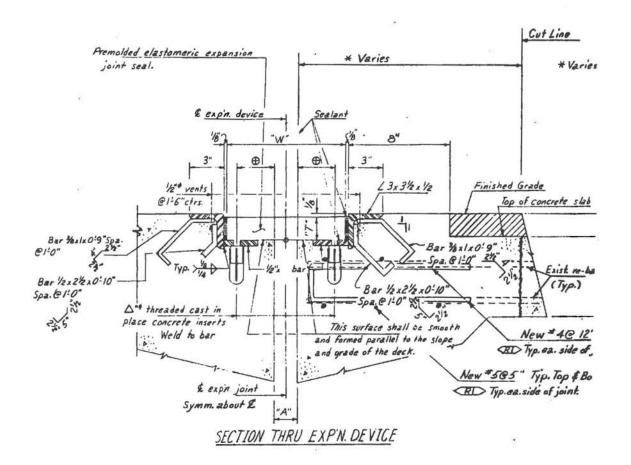
Diagram C

This general diagram is used for Fel-Pro, Onflex, Waboflex, and Transflex expansion joints. Dimensions are specified for each joint and each type of device on an individual basis.

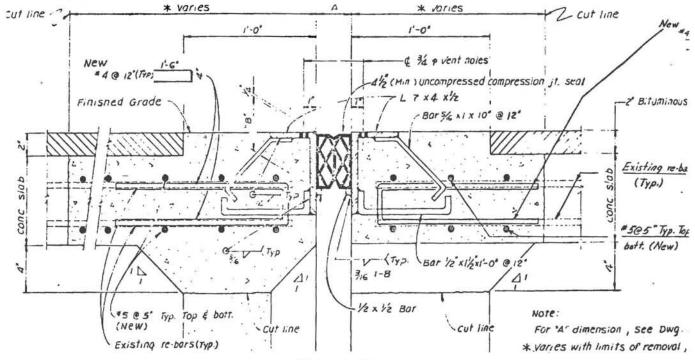
Diagram E

Neoprene Compression joint seal. A metal channel and bolts are used to maintain the proper "A" dimension.

An epoxy glue serves as a lubricant while the neoprene sealer is forced into place. The contractor encountered no problems with most of these joints on the 46th Avenue Viaduct. The metal angle iron parts were installed too close together on three joints and a special order for smaller neoprene strips was made.
